Fatigue fracture surface
characterization and investigation

Author: Magnus Dahlberg, Dave Hannes, Zhouwang Chen
Inspecta Technology AB, Stockholm, Sweden

Report number: 2016:28 ISSN: 2000-0456

Title: Fatigue fracture surface characterization and investigation
Author: Dave Hannes, Magnus Dahlberg, Zhouwang Chen
Inspecta Technology AB,
Stockholm Sweden
Date: 2016-08-24

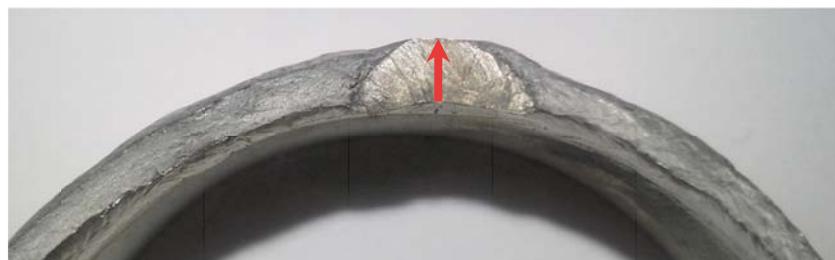
(a) Specimen 8.

The fatigue cracks initiated either from the inside or the outside of the piping component, see Figure 3. Internal fatigue initiation, at $R_i < r < R_i + t$, from for instance an interior material defect included in the pipe wall was not observed during the current investigation. Initiation from the inside corresponds to initiation from the weld root at $r = R_i$. As the test specimens were pressurized with water, such fatigue cracks were then in contact with water during the entire damage process, as opposed to fatigue cracks that initiated from the outside or weld cap, at $r = R_i + t$. This difference in environment most likely explains the observed difference in coloring of the fatigue crack fracture surfaces. The fatigue fracture surfaces of cracks initiated from the inside were in general slightly darker, when compared to those initiating from the outside.

Figure 3 Fatigue crack initiation from (a) inside, and (b) outside of the piping component. The (red) arrow indicates the propagation direction.

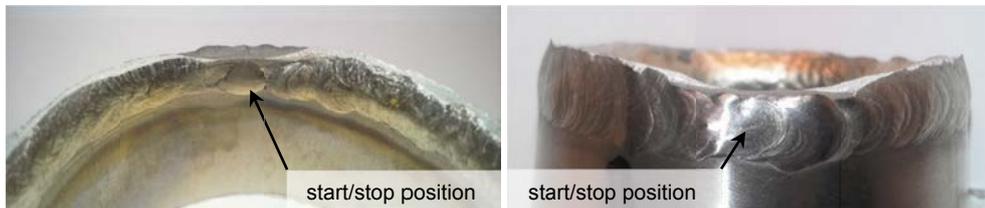
(a) Specimen 14.

The fatigue initiation position occasionally also observed to coincide with the weld start/stop position, see for instance specimen 14 in Figure 5 (a). The circumferential fatigue initiation position was affected by the detrimental residual stress state at the weld start/stop position. Finite element simulations have shown increased residual stresses at the start/stop position of the weld [4], which can explain localization of fatigue initiation.

Figure 5 Illustration of (a) weld cap toe crack initiation and (b) weld root face crack initiation, with views on the inside and outside of the weld joint.

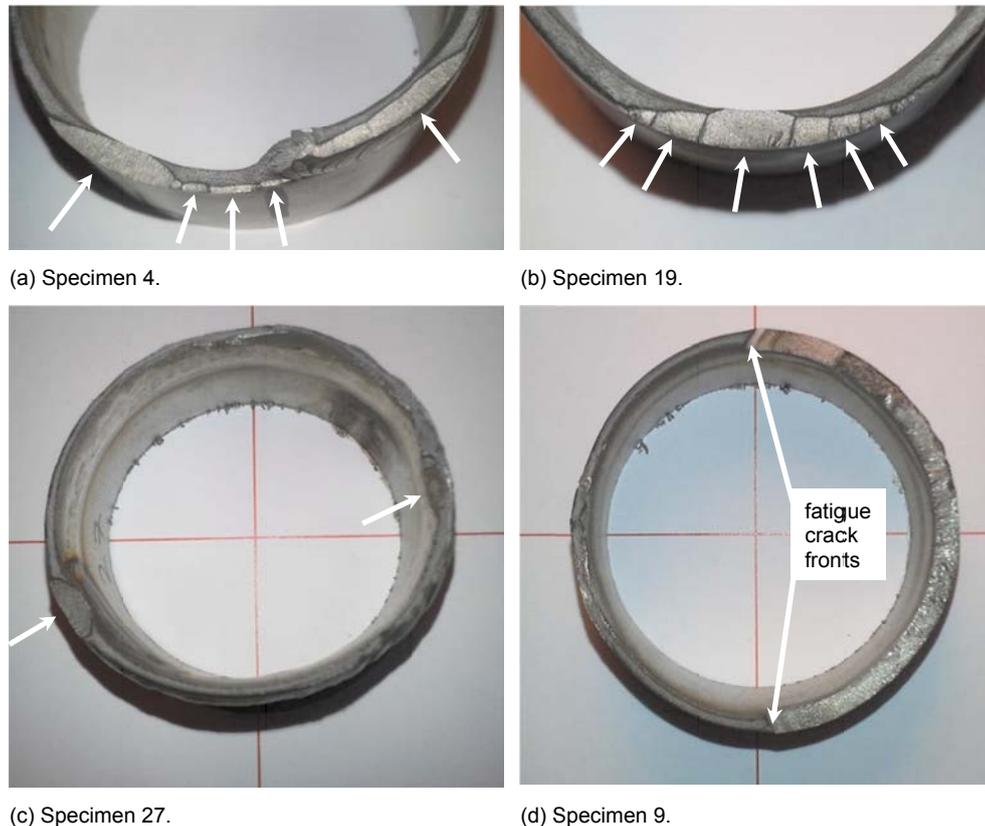
Figure 8 Illustration of multiple fatigue initiation sites, adjacent fatigue cracks and continued fatigue crack growth.

Table 3 represents the data for the dominant fatigue crack inducing leakage, but for several specimens multiple fatigue initiation sites were observed, see in particular Figure 8 (a) and (b), which resulted in separate or adjacent fatigue cracks. This occurred mainly in combination with initiation from the outside, which was identified as the prevailing initiation position at LCF. In particular multiple fatigue initiation always occurred for specimens subjected to large peak loads, i.e. with maximum nominal strain amplitudes larger than 0.18%, see Figure 7(a). As an example specimen 4 in Figure 8 (a) may be mentioned. This specimen experienced the largest nominal strain amplitude during the test program, which explains the large number of distinct fatigue cracks that initiated. The beta-norm in Figure 7(b) being an equivalent strain measure cannot reveal this feature related to fatigue initiation and was found more appropriate for the study of propagation.

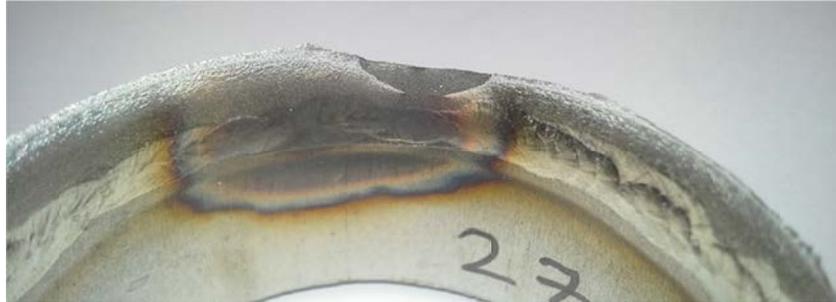
Specimen 27 may appear as a clear exception in Figure 7(a), as this piping component presented a dominant fatigue crack causing leakage starting from the outside although being subjected to a HCF load, but the investigation of its fracture surface also revealed at a different circumferential position a well-developed fatigue crack that had initiated from the inside, see Figure 8 (c), which agrees well with the prevailing damage process at HCF. The fatigue crack that started from the inside did not penetrate the entire wall thickness of specimen 27, but reached an

estimated crack depth of at least $0.8t$. The atypical initiation from the outside may be related to an event during welding, as suggested by the enhanced oxidation markings illustrated in Figure 9. A minor weld repair or improvement may have been performed at this location, which may be related to the somewhat increased weld cap height at this particular location. The modified residual stress state and expected higher stress concentration on the outside may be responsible for inducing fatigue initiation at this particular location.

Figure 9 Weld oxidation region coinciding with the fatigue initiation position from the outside for specimen 27.
