Effect of irradiation on microstructure of oxide films formed on highly irradiated stainless steel surfaces in PWR

Ringhals unit 2

Flux Thimble Tube

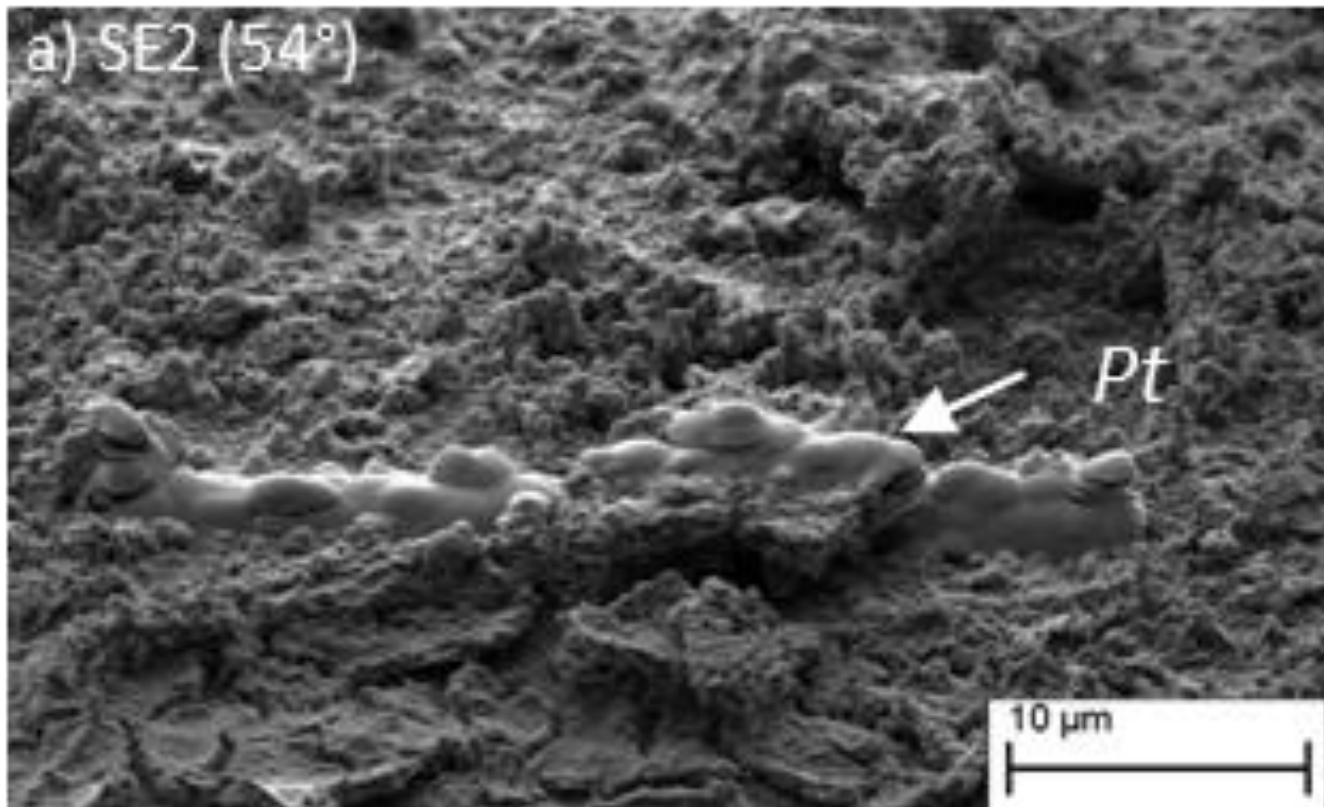
Oxide film morphology (0 dpa)

Corroded surface

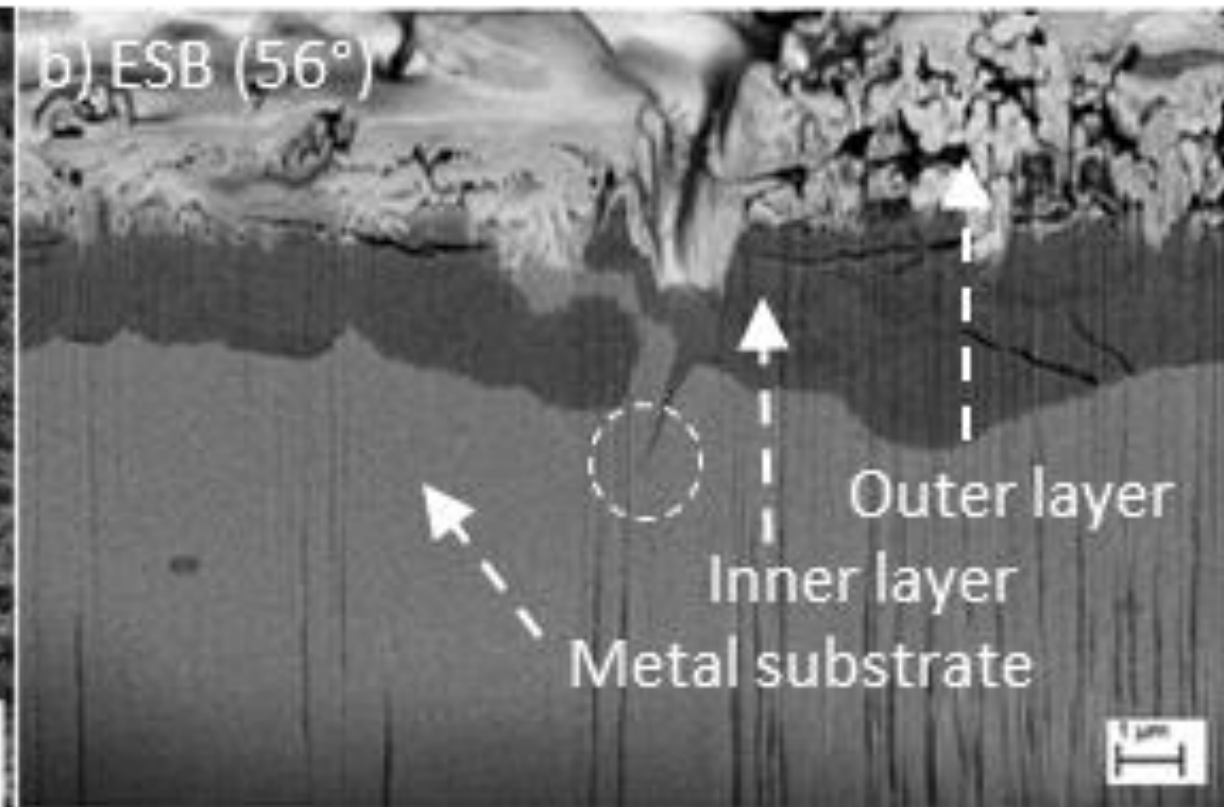
Cross section

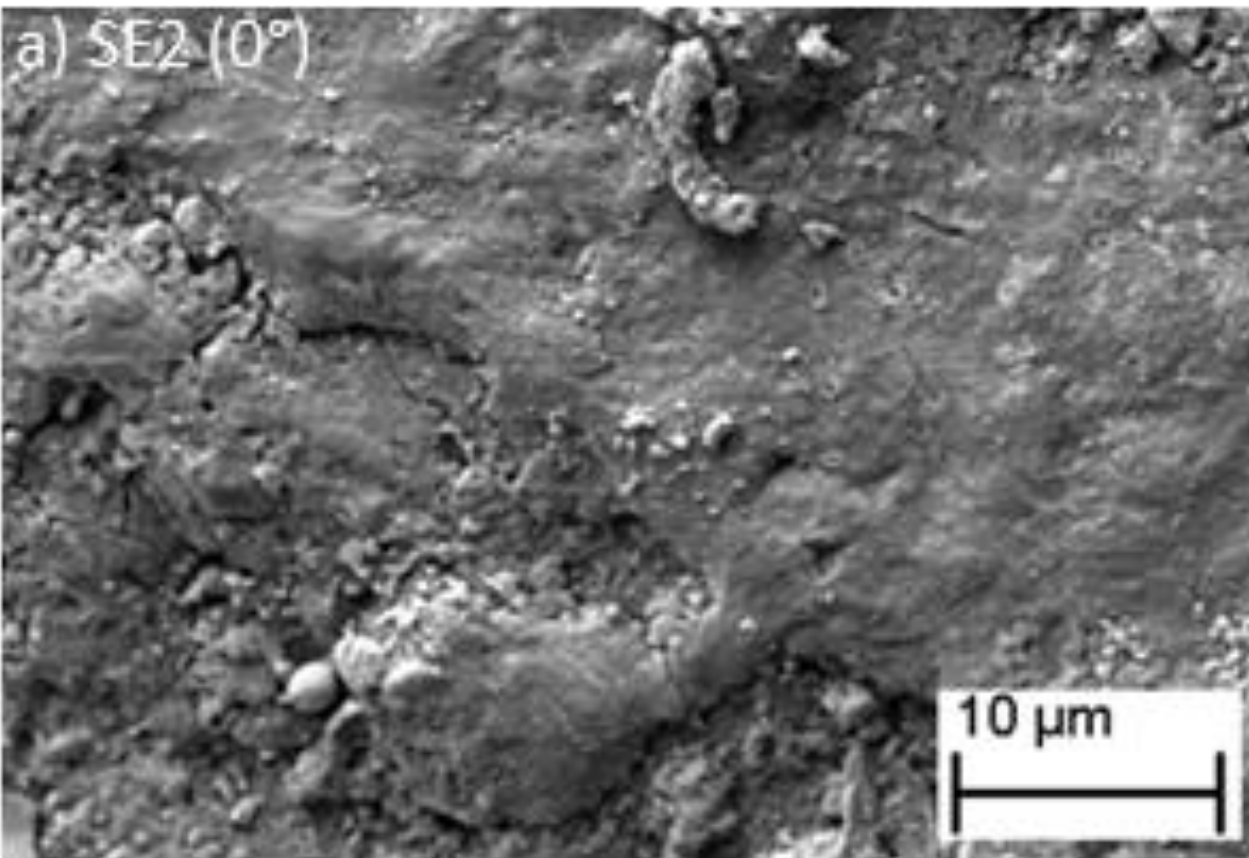
Oxide film morphology (50 dpa)

Corroded surface

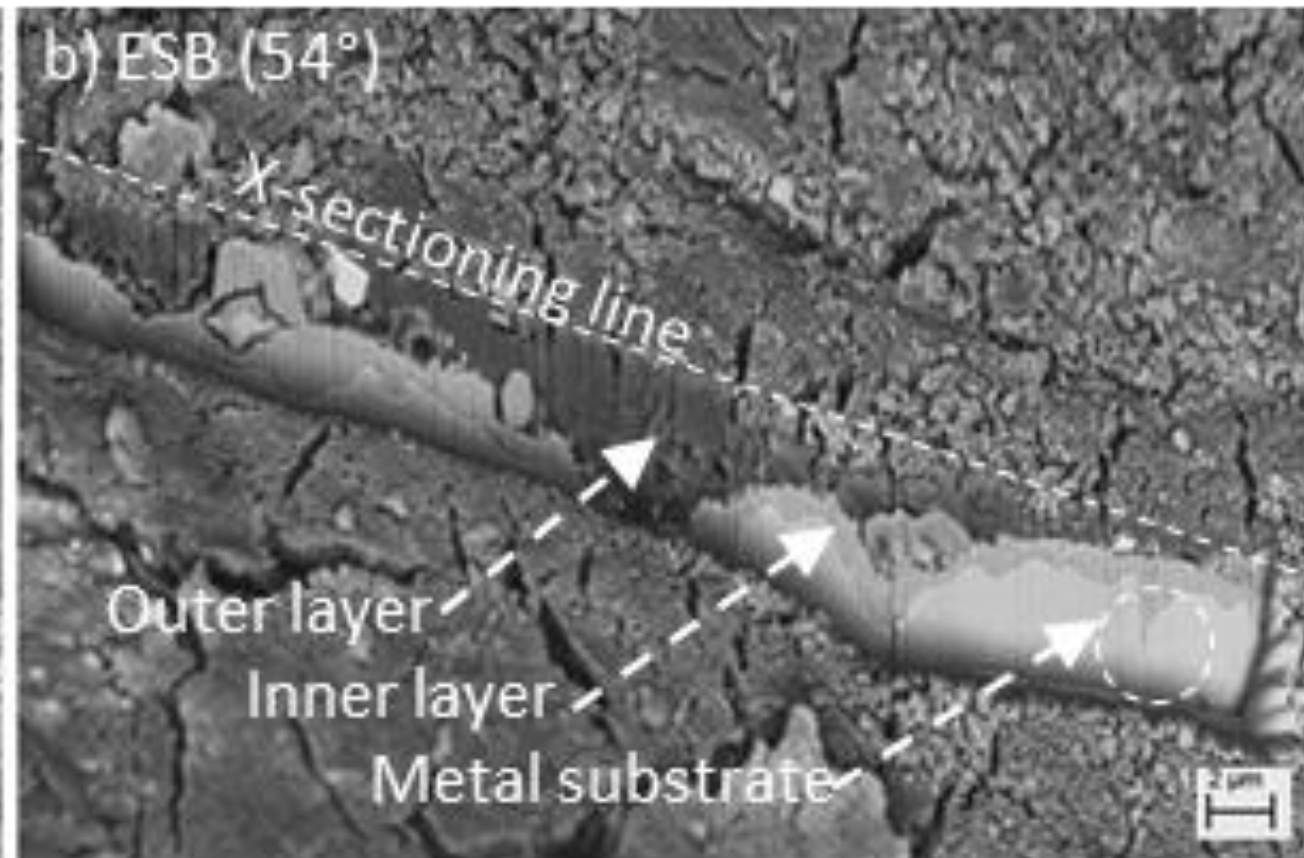
Cross section

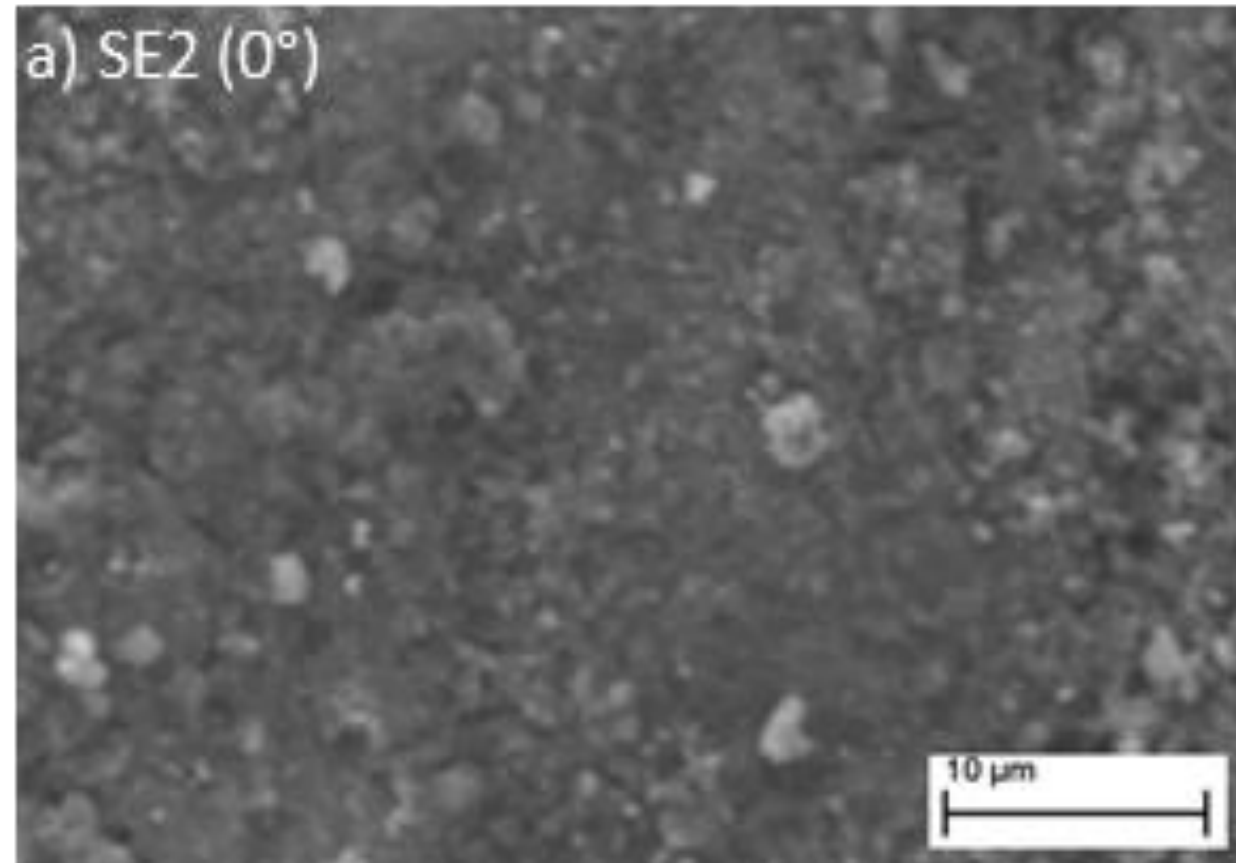
Oxide film morphology (100 dpa)

Corroded surface

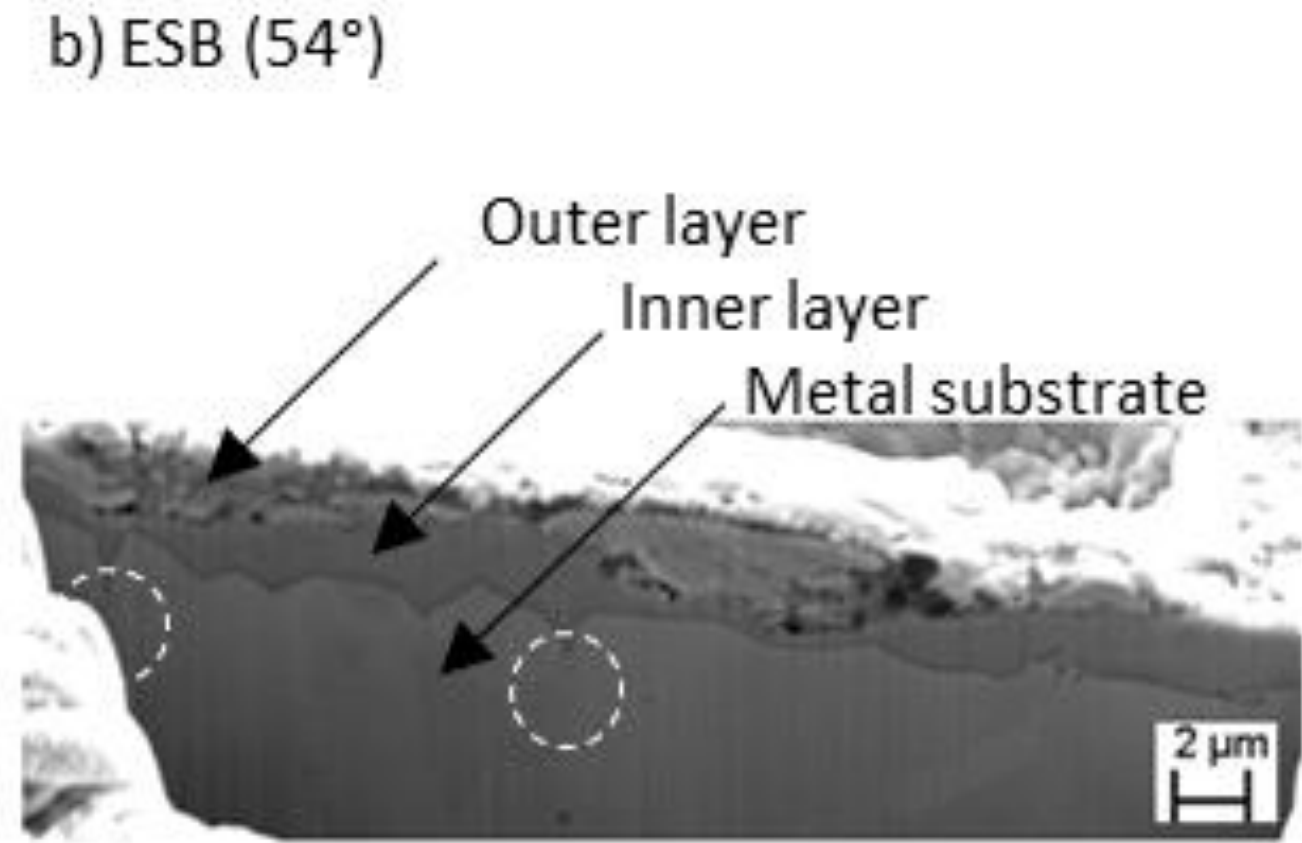
Cross section

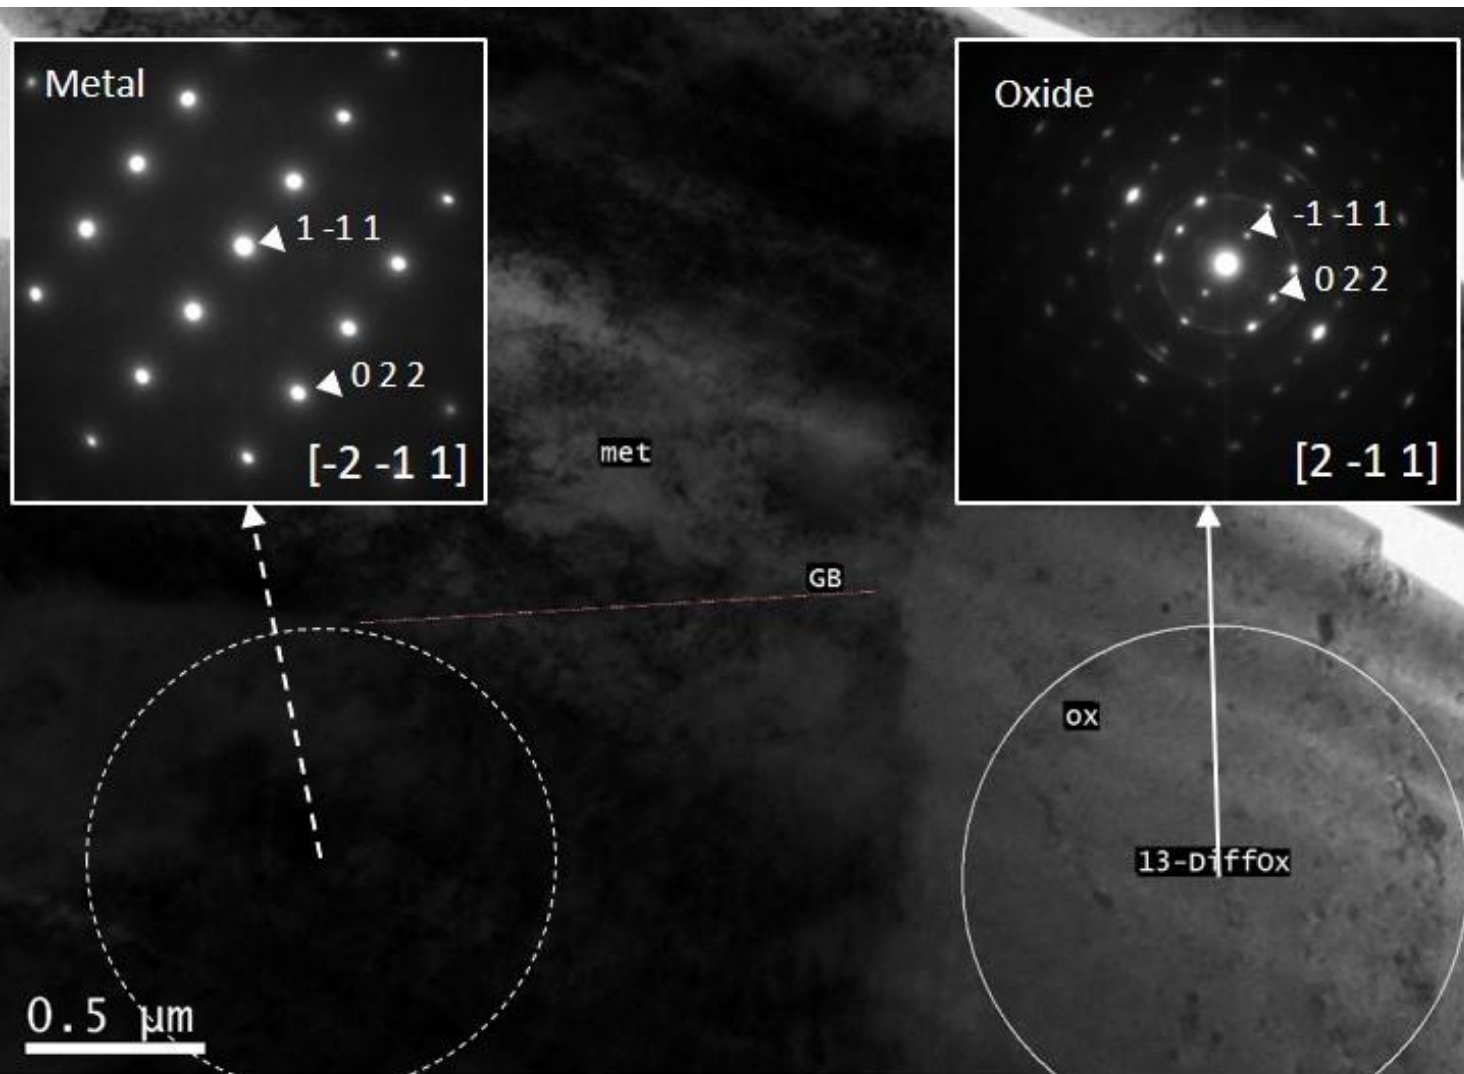
Compositions and crystal structures (0 dpa)

Outer layer

$\text{Ni}_{0.8}\text{Fe}_{1.5}\text{Cr}_{0.7}\text{O}_4$ grains

Inner layer

$\text{Ni}_{0.5}\text{FeCr}_{1.5}\text{O}_4$

Epitaxial

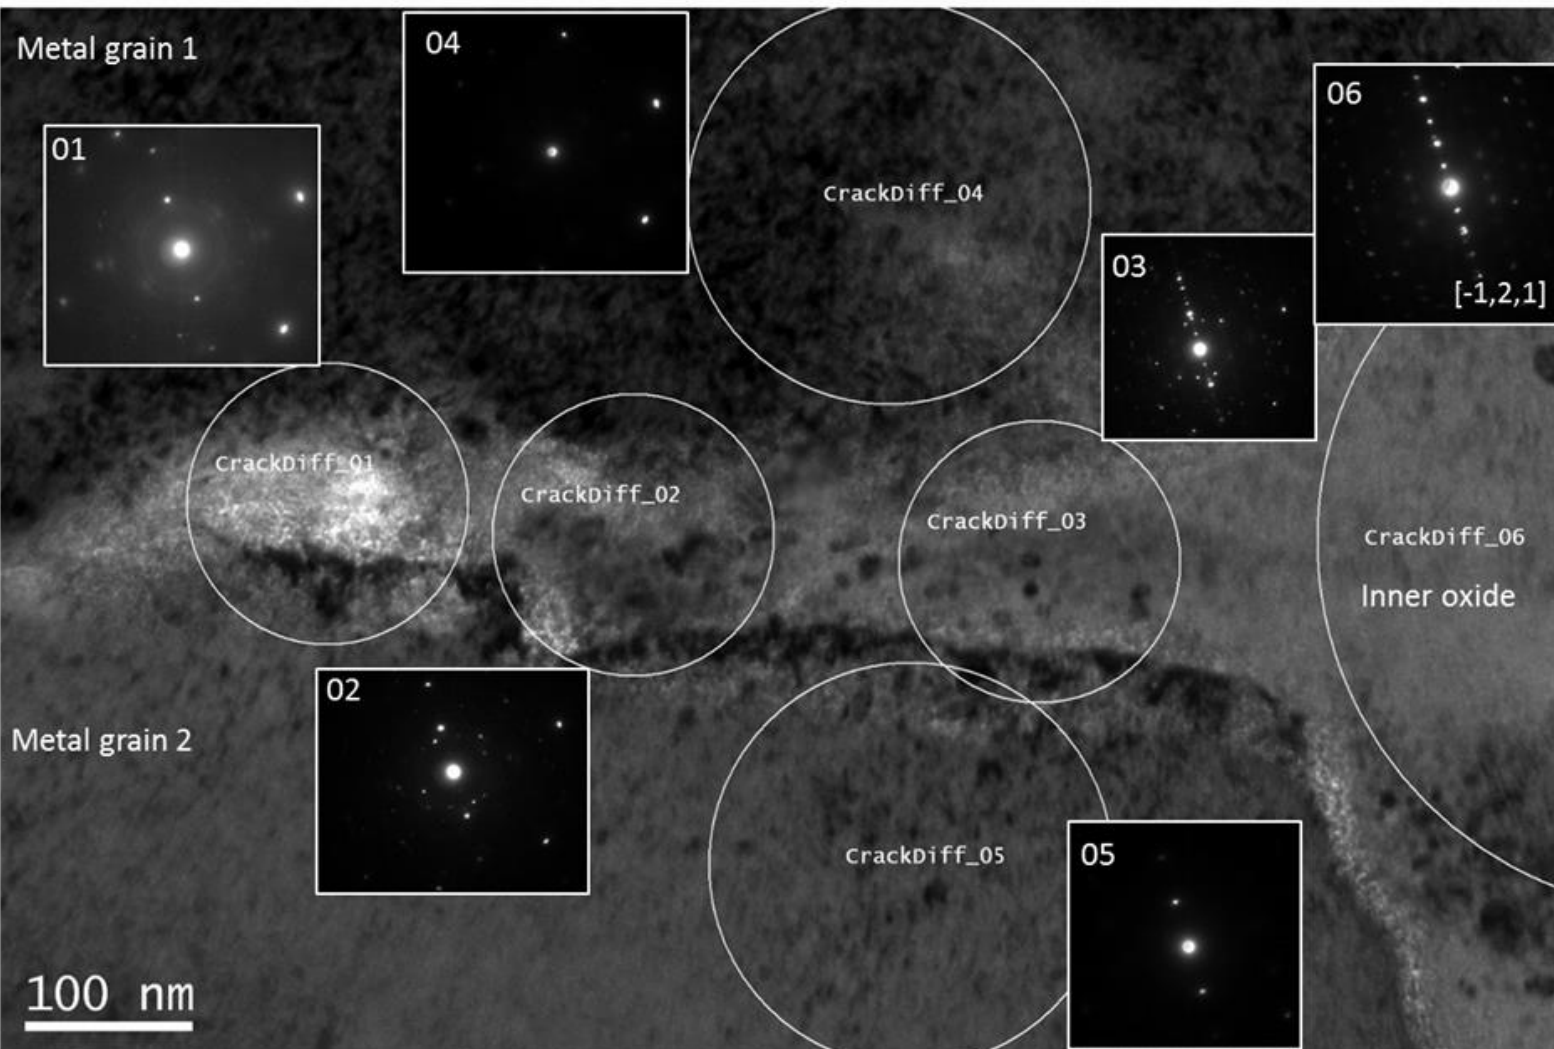
Compositions and crystal structures (50 dpa)

Outer layer

$\text{Ni}_{0.6}\text{Fe}_{1.6}\text{Cr}_{0.7}\text{O}_4$ grains

Inner layer

$\text{Ni}_{0.7}\text{Fe}_{1.1}\text{Cr}_{1.2}\text{O}_4$
Epitaxial

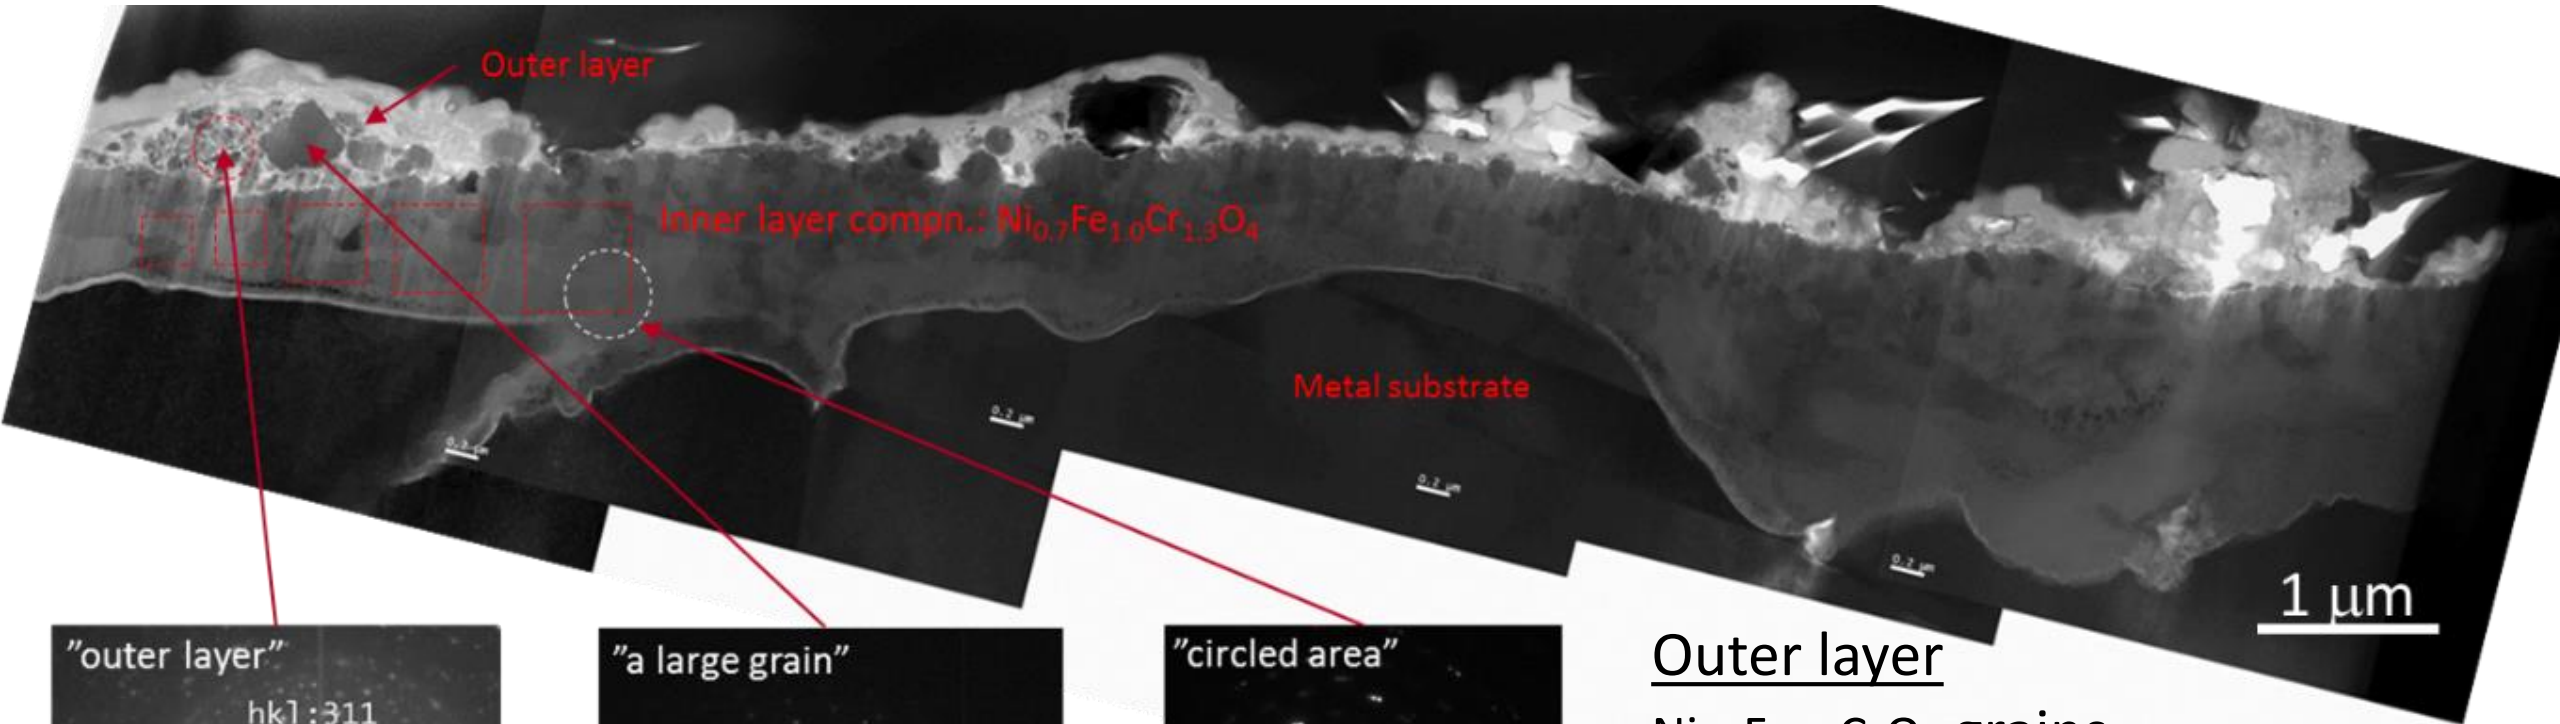
Compositions and crystal structures (100 dpa)

Outer layer
 $Ni_{0.8}Fe_{1.2}CrO_4$ grains

Inner layer
 $Ni_{0.7}FeCr_{1.3}O_4$
Epitaxial

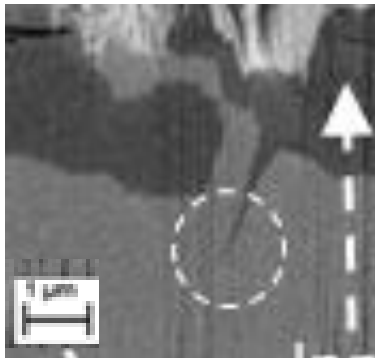
0 dpa

- Oxide intrusion at the inner oxide/metal substrate boundaries

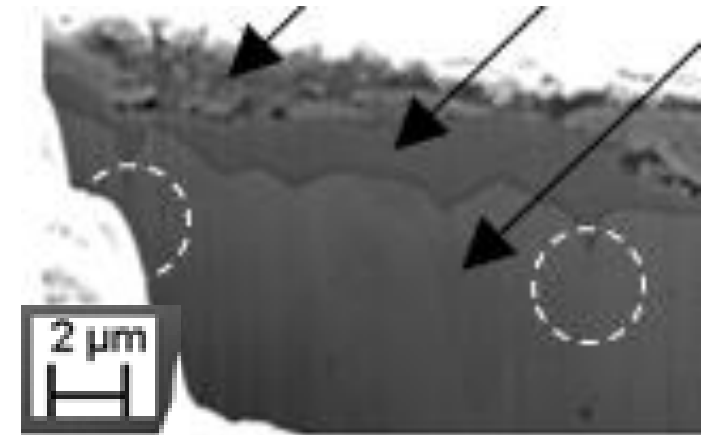
100 dpa

- At all three dose levels, oxide penetration was observed at some metal/metal grain boundaries.
 - However, the penetration depth was only about 1-2 μm .
- All oxide films consisted of a duplex layer structure
 - an outer porous layer of fine spinel grains and an inner dense layer of epitaxially grown spinel.
- For the TEM-lamella “0_dpa” slight chromium enrichment was detected at the metal/metal grain boundaries near the oxide film, whereas for the TEM-lamella “50_dpa” no such enrichment or depletion could be clearly identified.
- The present study has not provided any evidence of irradiation enhanced corrosion of the stainless steel material.
