SKI Rapport 2005:32
SSI Rapport 2005:05

Safety and Radiation Protection at Swedish Nuclear Power Plants 2004

May 2005

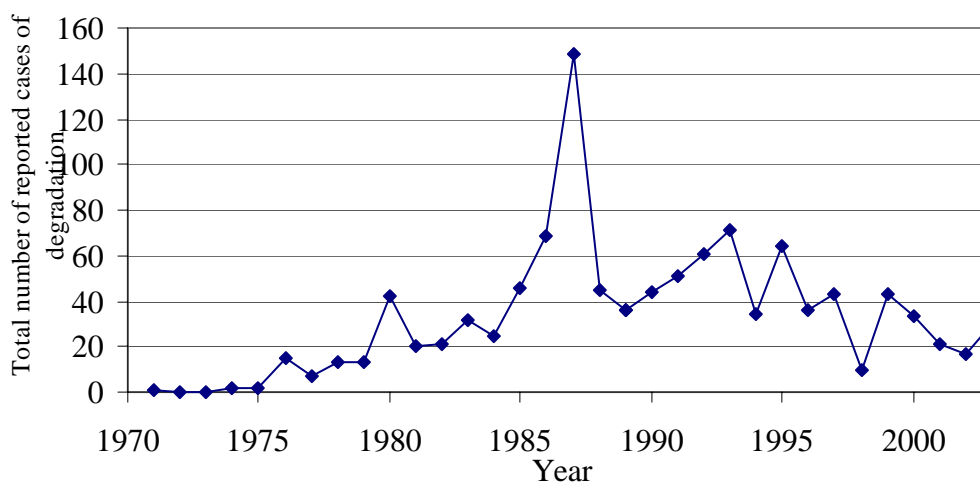
Diagram 1.

This conclusion applies even when the cases of degradation that occurred up to the end of 2004 are taken into account. As shown in *Diagrams 1* and *2* (pages 18 and 19), there is no tendency towards an increase in the number of cases as the plants become older.

Total number of reported cases of degradation per year at Swedish nuclear power plants. Degradation in steam generator tubes is not included.

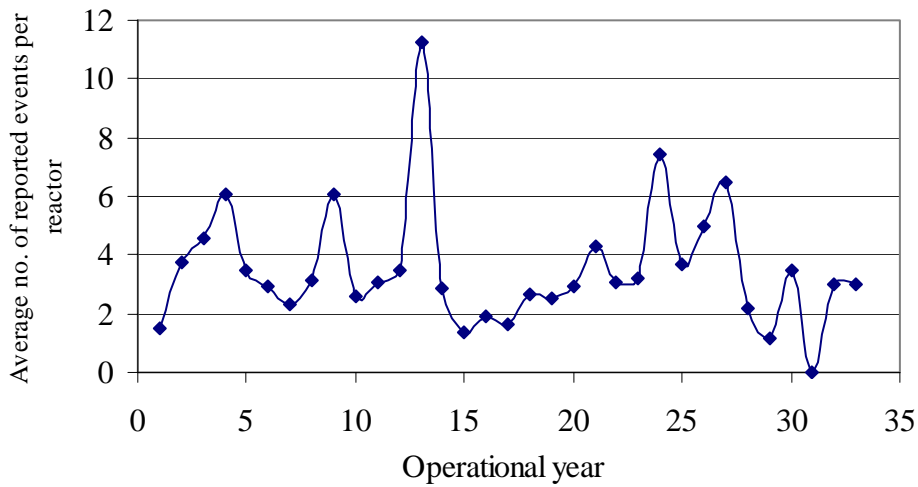
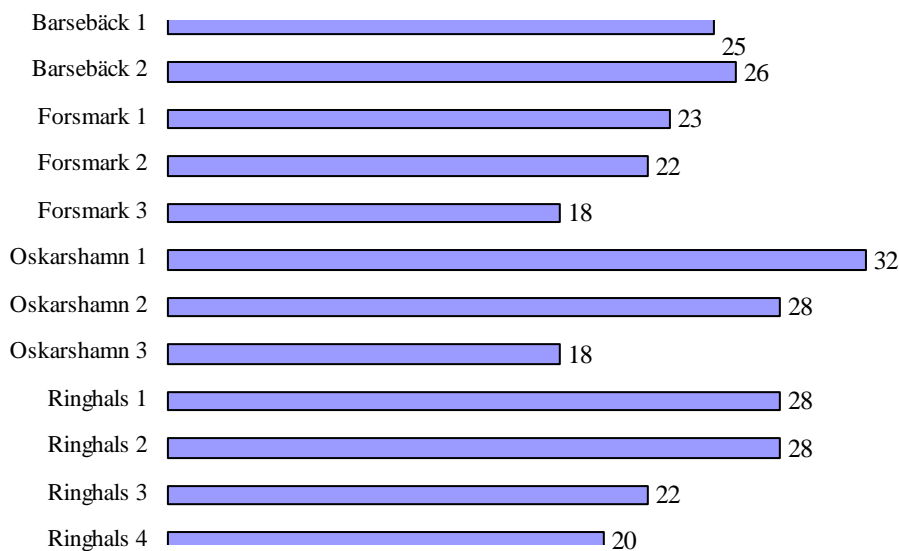
⁶ Note that most of the cases of degradation that occurred from 1986 to 1987 (see *Diagram 2*) after 13 to 14 years of operation (see *Diagram 3*) were caused by stress corrosion in cold-worked pipe bends. These were subsequently replaced by bends that were not cold-worked.

Diagram 2. The uppermost of the two diagrams shows the average number of reported cases of degradation per unit and operating year for all Swedish nuclear power plants. The diagram comprises degradation to pressure vessels, pipelines and other mechanical devices apart from steam generator tubes. The diagram below shows the number of operating years for the different units.

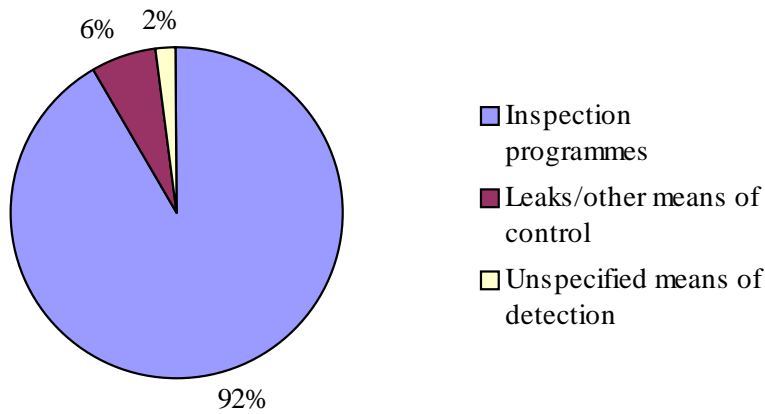
The overall evaluation also shows that most of the degradation that has occurred to date was detected in time through periodic in-service inspection and testing before safety was affected. Only a small portion of all of the degradation has led to leaks or other serious conditions as a result of cracking and other degradation which remained undetected, see *Diagram 3*.

Diagram 3. *The number of cases of degradation detected through periodic in-service inspection and testing and the number of instances of degradation that have resulted in leakage or that have been detected in some other way.*

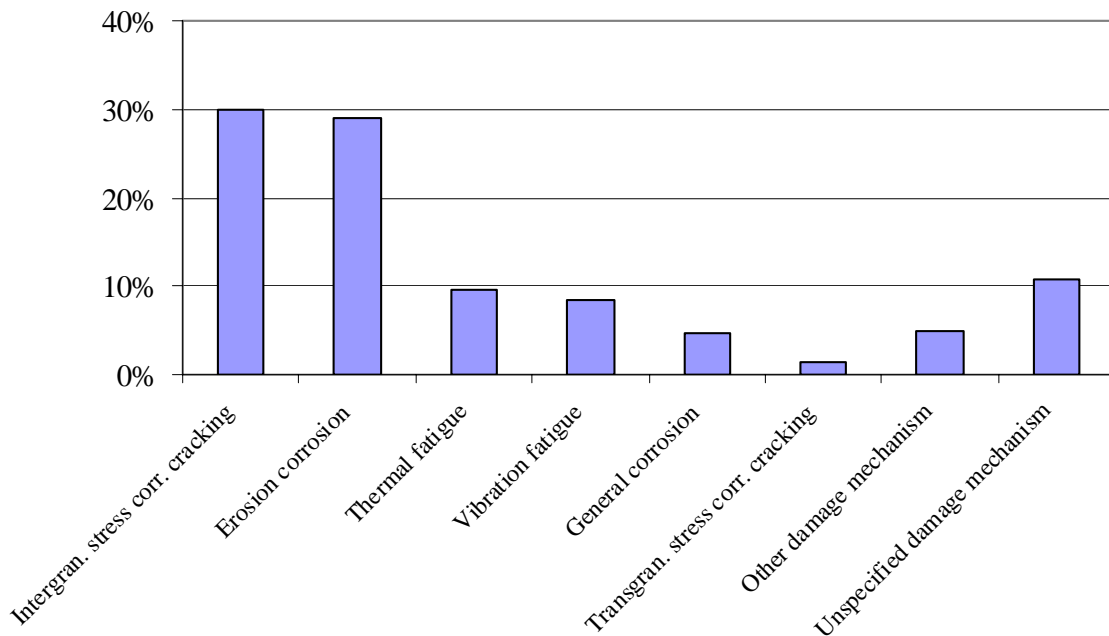
It is mainly different types of corrosion that have resulted in the cases of degradation mechanism which have occurred, see *Diagram 4* (page 20). The most common degradation

mechanism is intergranular stress corrosion cracking. The second most common degradation mechanism is erosion corrosion.

Diagram 4. *Cases of degradation sorted according to degradation mechanism. ("Other degradation mechanisms" includes cases of damage caused by grain boundary attack, corrosion fatigue and mechanical damage).*

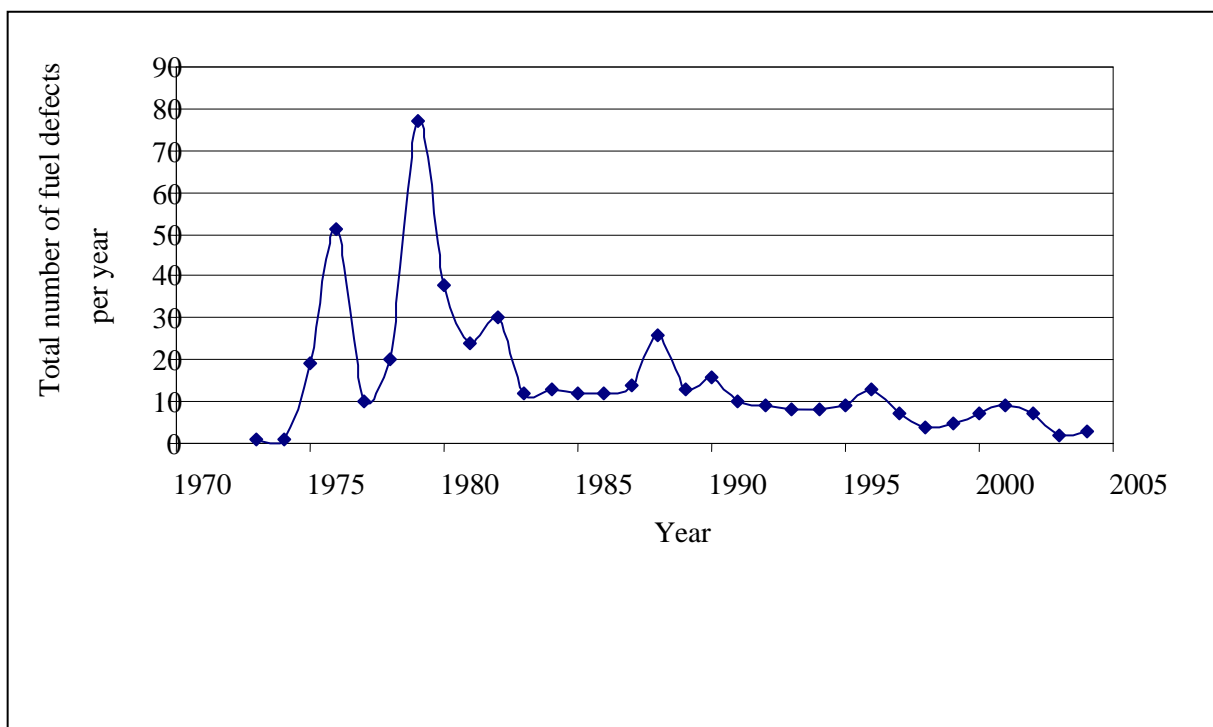
Diagram 5.
Total number of reported fuel defects per year at the Swedish nuclear power plants.

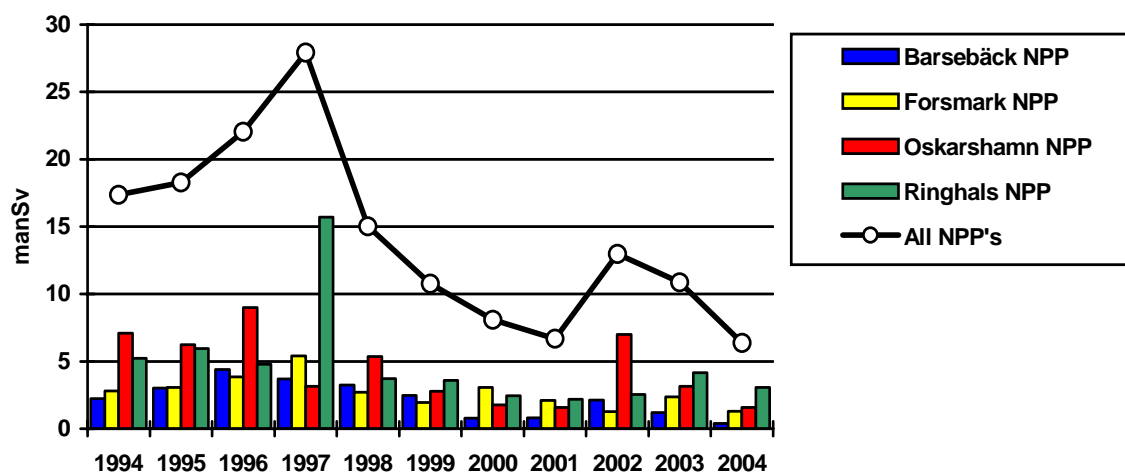
In 2004, the collective dose, including sub-contractors, at Swedish nuclear power plants was 6.4 manSv. The collective dose was lower than in 2003 (2003: 11 manSv; 2002: 13 manSv) and lower than the average, 9 manSv, for the past five years. During the year, 3,664 people received a registered effective dose. Diagram 6 shows the collective dose at the nuclear power plants for the period of 1994 to 2004.

Diagram 6: Annual collective dose (manSv) at Swedish nuclear power plants..

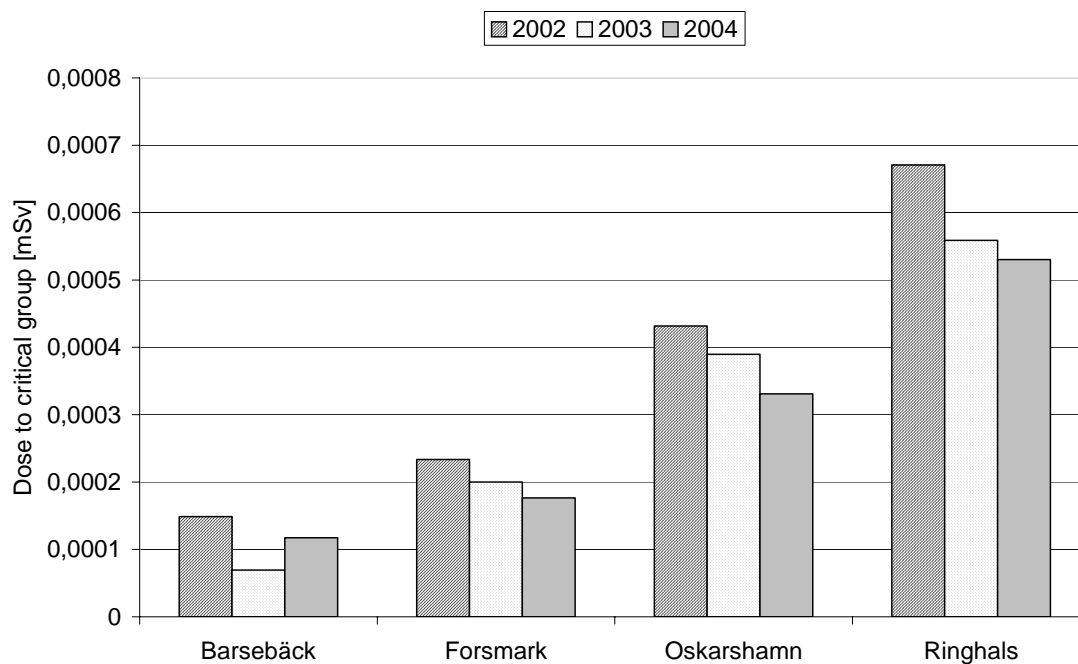
Diagram 7 shows the radiation doses that resulted from radioactive releases in 2004. The radiation doses (specified in mSv) concern people living close to a nuclear power plant who are estimated to receive the highest dose, known as the *critical group*. The dose constraint for an individual in the critical group is 0.1 mSv per year. The doses were all less than one-hundredth of the dose constraint.

Diagram 7: Radioactive releases to air and water from nuclear power plants in 2002-2004, shown as the dose to the critical group.
