# **Observations on Hydride Structures at the Tip of Arrested Cracks Grown under Conditions of Delayed Hydride Cracking**

April 2003

SKI:s projekthandläggare: Jan in de Betou  
SKI:s projektnummer: 99135

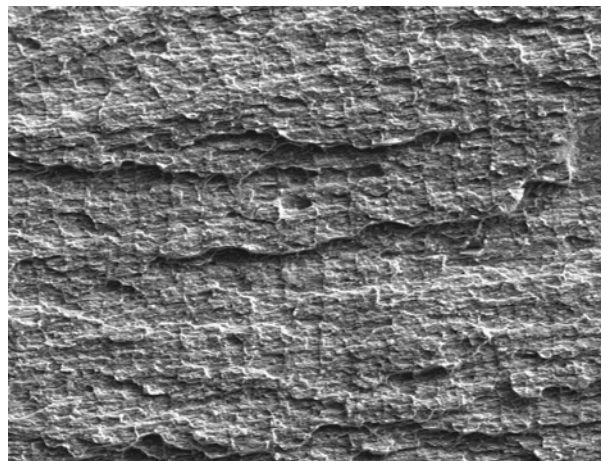
Figure 1. The typical appearance of a DHC fracture surface in Zr2.5Nb. 200x.

is a fracture surface from one of the other Zr2.5Nb specimens tested in Studsvik, The direction of crack growth is to the right in the figure. It is clear from the picture that the crack propagates on different planes separated by nearly vertical faces. The arc shaped features running mainly perpendicular to the crack growth direction are the so-called striations. The striations were initially associated with jumps in the crack length

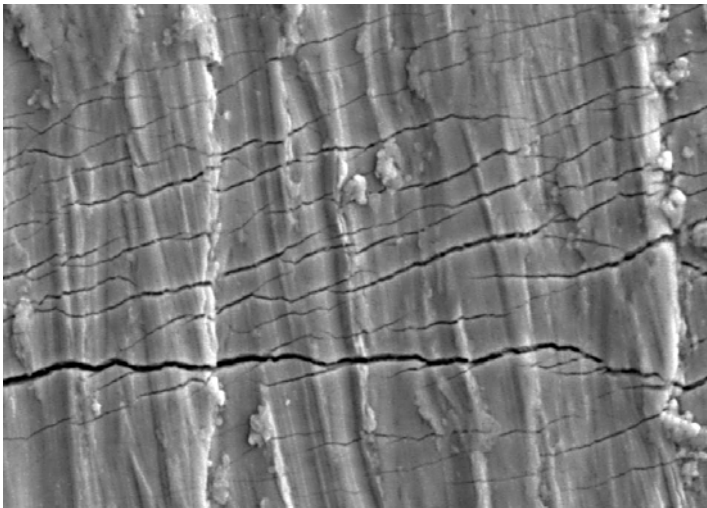
Figure 2. Fine cracks observed in association with the main crack. 1000x.

these cracks have formed in connection with the growth of the main crack. On the inner surface a pattern of these fine cracks seemed to emanate from the tip of the main crack in about  $\pm 30^\circ$  angle to the crack plane. The presence of these cracks is taken as an

indication that part of the electrolytically applied hydride layer had not been completely dissolved during the homogenization treatment.

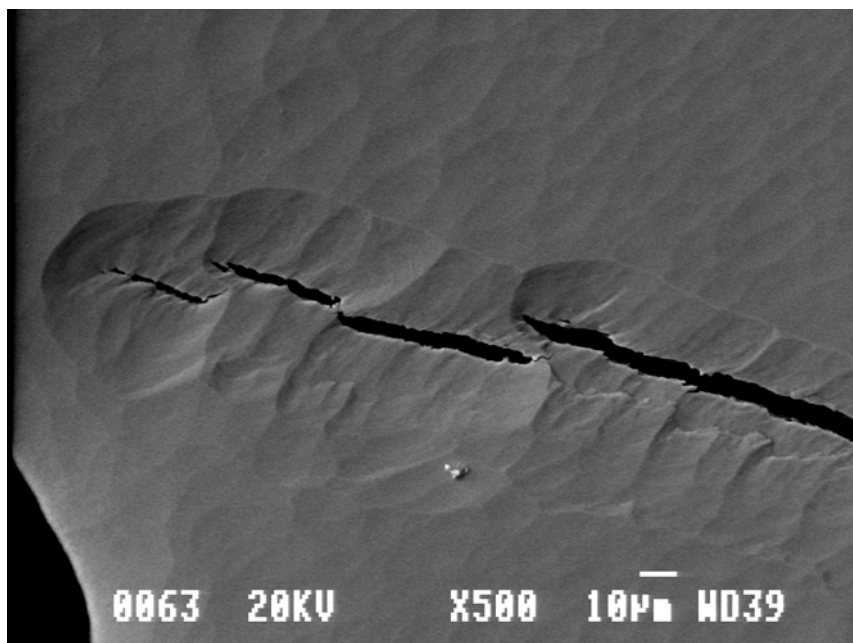
Figure 3. A crack tip as observed in SEM. 500x.

To the left in the picture we see the edge of a big hole. Ideally some further ion beam etching would make the area around the crack tip thin enough to be electron transparent. Unfortunately this particular specimen was lost during handling. The picture illustrates a couple of interesting features. It can be seen how the crack has grown on different planes with unbroken ligaments between in this particular cross section. At a later stage of crack growth these ligaments will of course be broken. Another interesting feature of the figure is the unevenness of the surface caused by the ion beam etching. It is particularly interesting to see how the unevenness has been influenced by the crack. Similar features could be seen on all the foils after ion beam thinning.

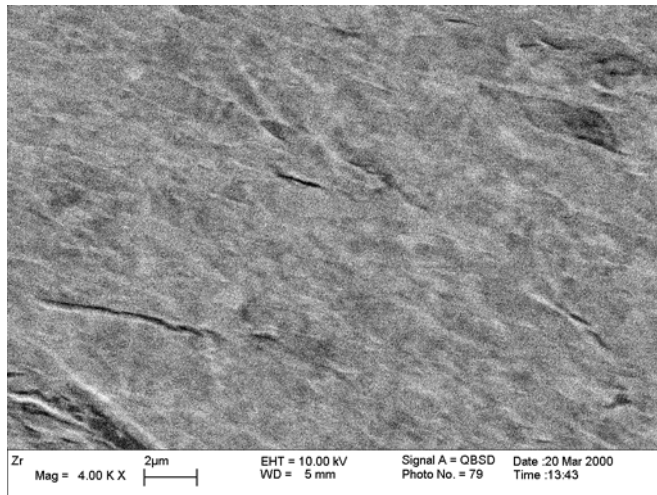
A few of the foils were also observed in a FEG-SEM. Figure 4 shows a picture where the backscatter detector has been used. In that way any hydrides will be seen in a somewhat darker contrast than the matrix while the topography of the type seen in Figure 3 gives a weak contrast. Two hydrides can be seen in the picture. The one in the

lower left corner has a length of about 5  $\mu\text{m}$  while the one in the middle has a size of somewhat less than 2 $\mu\text{m}$ .

Fig 4. The surface of one of the foils as observed in SEM. 1000x.

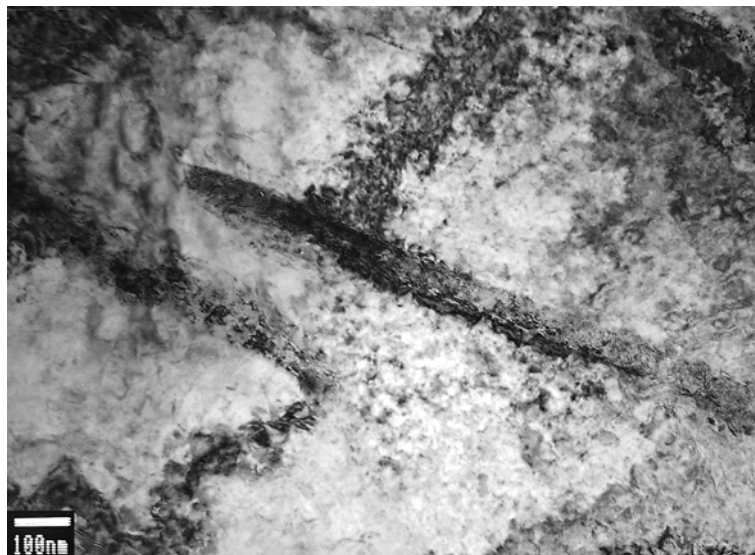
Figure 5. The microstructure in  $\text{Zr}_{2.5}\text{Nb}$ . A hydride can be seen in the middle of the figure. x80k.

The hydride seen in the middle of Figure 5 is typical of the hydrides observed in the specimens prepared. Due to the complexity of the microstructure, probably including

the presence of Nb rich  $\beta$ -phase it was impossible to evaluate the recorded diffraction patterns with regard to the form of the hydride phase. In most cases the diffraction spots seemed to fit better with the  $\gamma$  phase than the  $\delta$   $\square\square\square\square$ . On the other hand the (110) reflections unique to the  $\gamma$  phase [11] were never observed so it seems most probable that the hydrides are of the  $\delta$  type.

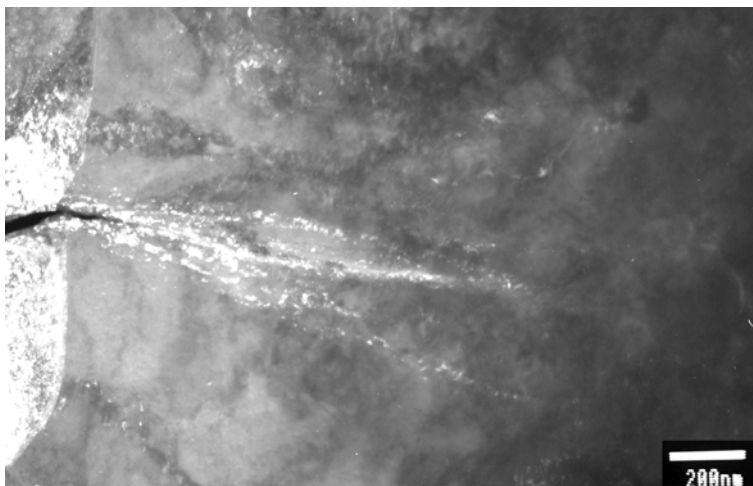
In one of the specimens a number of cracks emanated from the central hole. Figure 6 shows a dark field picture of some streaks starting at the tip of one of those cracks. Unfortunately the diffraction spot used for the dark field imaging does not correspond to any plane in any hydride so it is uncertain what these streaks actually represent. It is not even certain that this crack tip is the tip of the DHC crack. It may well have been formed in connection with the specimen preparation. However it is possible to speculate that what is seen in the picture may be the memory of intense shear deformation of the type proposed by Gregoriev as associated with DHC growth [7].

Figure 6. A dark field image of streaks emanating from a tip of a crack. x50k.

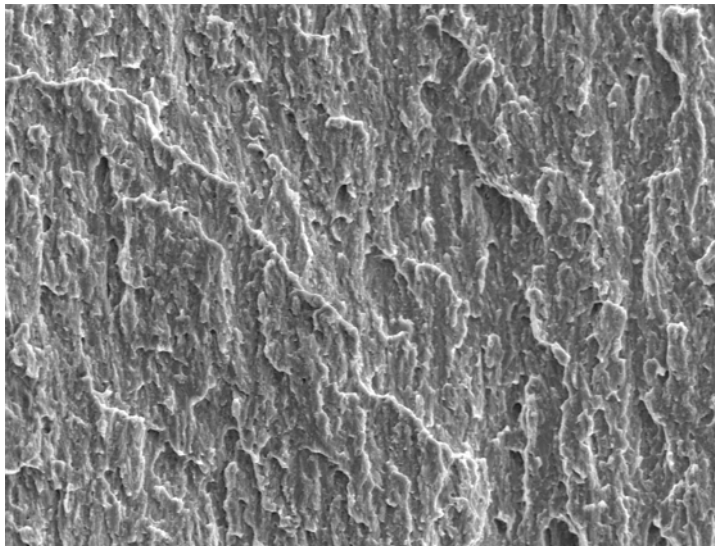
On one Zr-4 specimen the fracture surface was examined. A typical view of the DHC fracture surface can be seen in Figure 7. The direction of crack growth is from bottom to top in the figure. In comparison with Figure 1 from the Zr2.5Nb specimen it can be noted that there are no striations on this fracture surface. This perhaps indicates that the DHC crack growth in cladding tube is a more continuous process than in the Zr2.5Nb pressure tube material.

Figure 7. The DHC fracture surface on a Zr-4 specimen. x500.

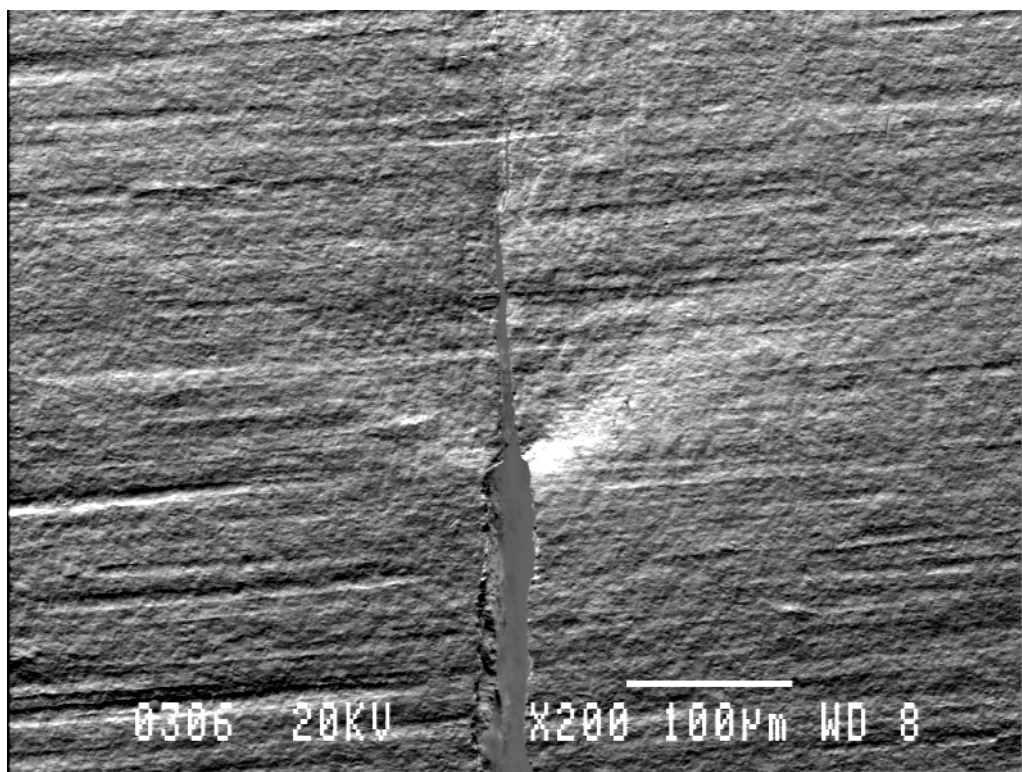
Figure 8. The surface of a Zircaloy-4 specimen DHC tested by the pin-loading method. x200.

The plastic zones formed when the specimen was loaded for DHC testing are clearly visible. It is also possible to measure a crack opening displacement value of 25  $\mu\text{m}$ . The actual DHC crack is more narrow and the crack tip is located about 1.07 mm from the blunted tip of the fatigue crack. This and subsequent values of the location of the crack tip were measured by moving the specimen with the Y control knob of the specimen stage and reading the micrometer attached to the knob. The edge of the specimen was used as a reference point.

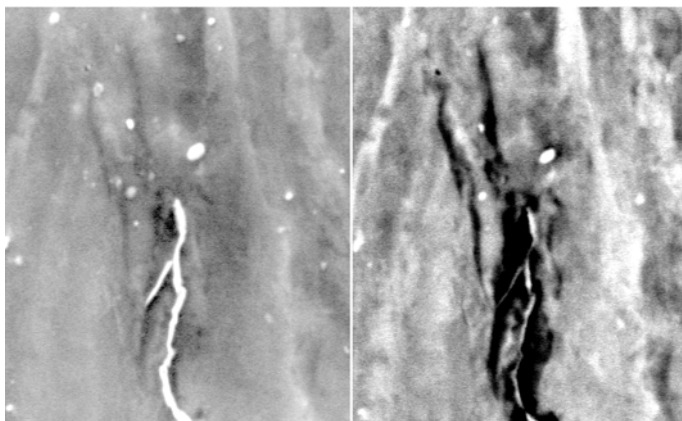
Figure 9. The crack tip at a depth of 0.05 mm. The SE image to the left and the BE image to the right. 5000x.

If there are hydrides present they are expected to give a darker contrast than the zirconium matrix in the BE image. On that basis one might conclude that the crack faces at the crack tip consist of hydride and that there are two hydride plates in front of the crack tip. This is of course exactly the type of structure expected at the crack tip according to classical theories of DHC.

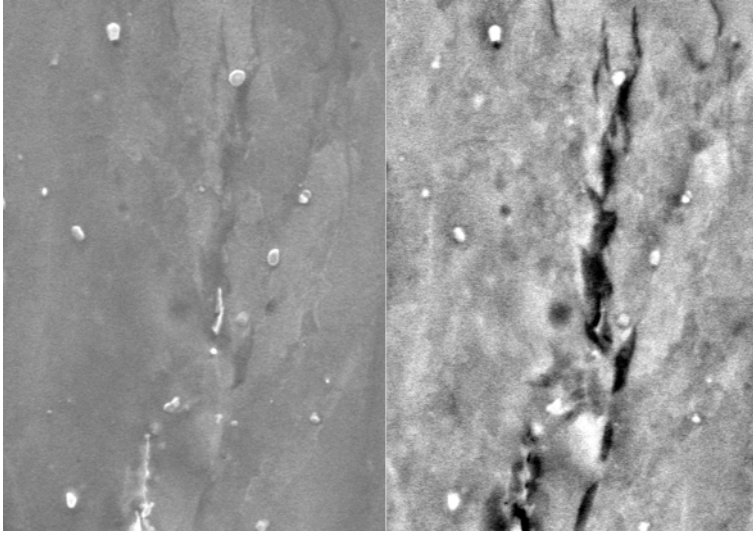
Figure 10. The crack tip at a depth of 0.162 mm. In the SE image to the left the crack is seen as a light streak. There seems to be a bridge of metal between the ultimate crack tip and the main crack. 5000x.

The structure seen in Figure 10 is basically similar to the structure seen in Figure 9. There is considerable dark contrast along the crack and also extending beyond the tip of the crack indicating the presence of hydrides. However when the specimen was etched for hydrides there was no response to the etching with regard to hydrides. It should be noted that another specimen known to contain hydrides was etched at the same time and in that specimen the hydrides became quite visible after etching. On the basis of this observation there must be some doubt that the dark contrast in the BE image is actually due to the presence of hydrides.

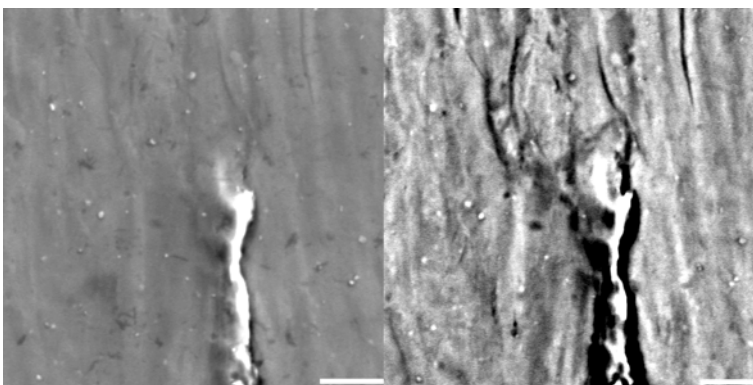
Figure 11. The crack tip at a depth of 0.19 mm. 2000x.

The microstructure is basically similar to that seen in the previous two figures with a dark contrast layer along the crack faces and plates of dark contrast extending from the tip of the crack.

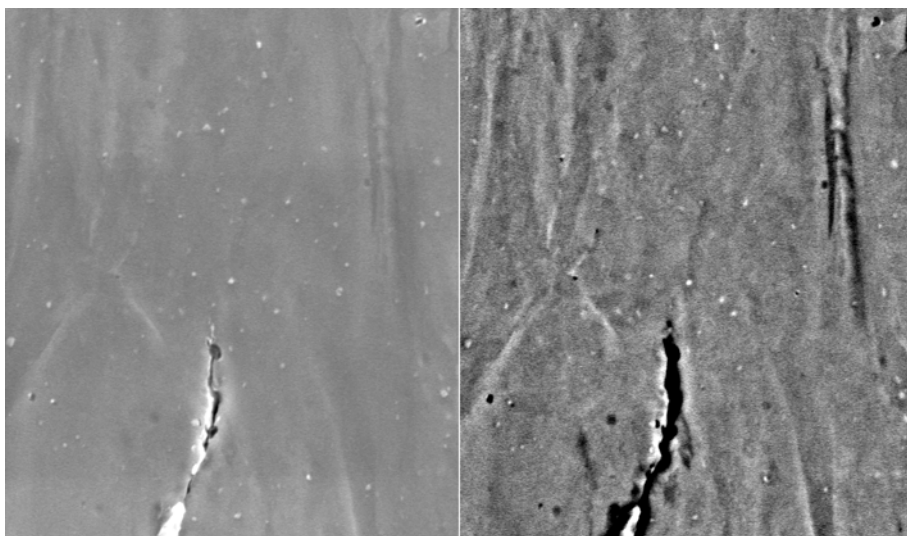
A fourth cross section at a depth of 0.235 mm was also examined. The composite picture, Figure 12, shows that there is in this case no contrast extending beyond the crack tip.

Figure 12. The crack tip at a depth of 0.235 mm. 2000x.

Two plate-like features can be seen in the upper right corner of the figure. It is also interesting to note that there are lots of other darkish features elongated in the direction of crack growth. These features are tentatively interpreted as belonging to the cold worked stress relieved microstructure of the material. The question which arises is whether or not the darkest features also are a result of this high dislocation density structure. The absence of any hydride etching response in cross section 2 supports such an interpretation. On the other hand the fact that the darkest features are observed exactly where we would expect hydrides to be present supports the interpretation that they are in fact hydrides. The absence of hydride plates ahead of the tip in cross section 4 can be understood if we assume that the test was interrupted at a time when the tip in this cross section just had made a jump. With this interpretation our observations tend to support the classical DHC theory rather than the hydrogen enhanced localized shear theory.

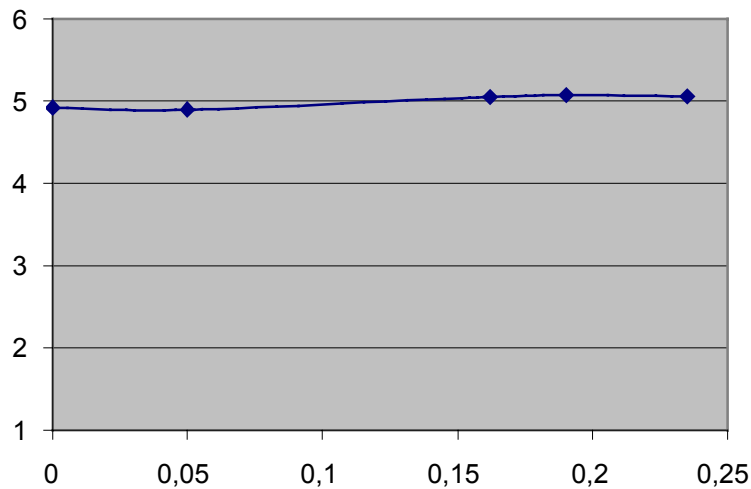
Figure 13. The position of the crack front at the five depths where it was measured. Both axes are graded in mm.

This shape of the crack front is quite surprising. On all other specimens the front has had a typical thumb nail shape where the front near the surface has lagged behind the inside with typically about 0.3 – 0.5 mm. The question is whether or not this indicates a problem with doing the flat cross section in the way we have done. It is not immediately obvious what this problem might be.

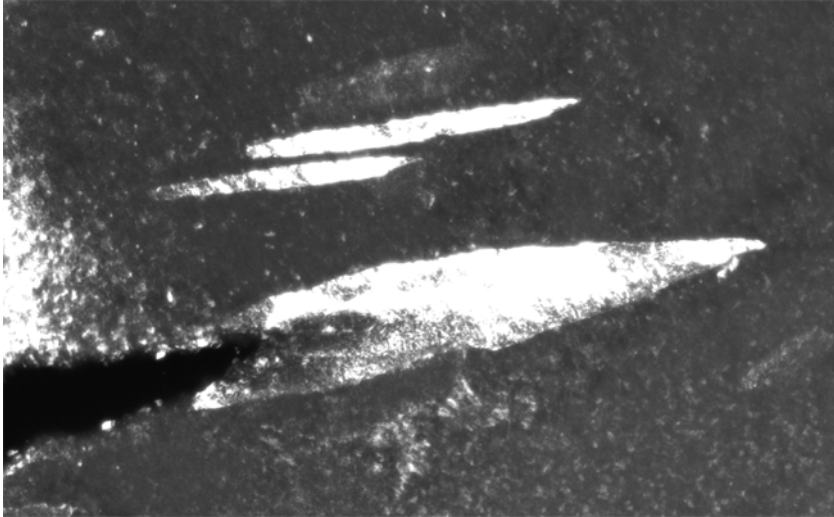
After the last examination of the cross section the area containing the crack was cut out of the ring specimen and thinned down mechanically from both sides. Final thinning with the aim of obtaining a thinned area at the tip of the crack was performed by ion milling. Figure 14 shows one example of a crack tip observed in the thin foil where a hydride is located at the tip. The picture is a dark field image taken with the (200) reflection of delta hydride. Unfortunately the quality of the diffraction pattern did not permit any good identification of directions in the picture. However the  $\langle 200 \rangle$  direction in the hydride coincided with the  $\langle 10 \bar{1} 0 \rangle$  of the matrix.

Figure 14. A dark field image of hydrides in association with the tip of a crack. 30000x.
