# Whiskers and Localized Corrosion on Copper in Repository Environment

Hans-Peter Hermansson  
Peter Gillén

March 2004

Studsvik Nuclear AB  
SE-611 82 Nyköping  
Sweden

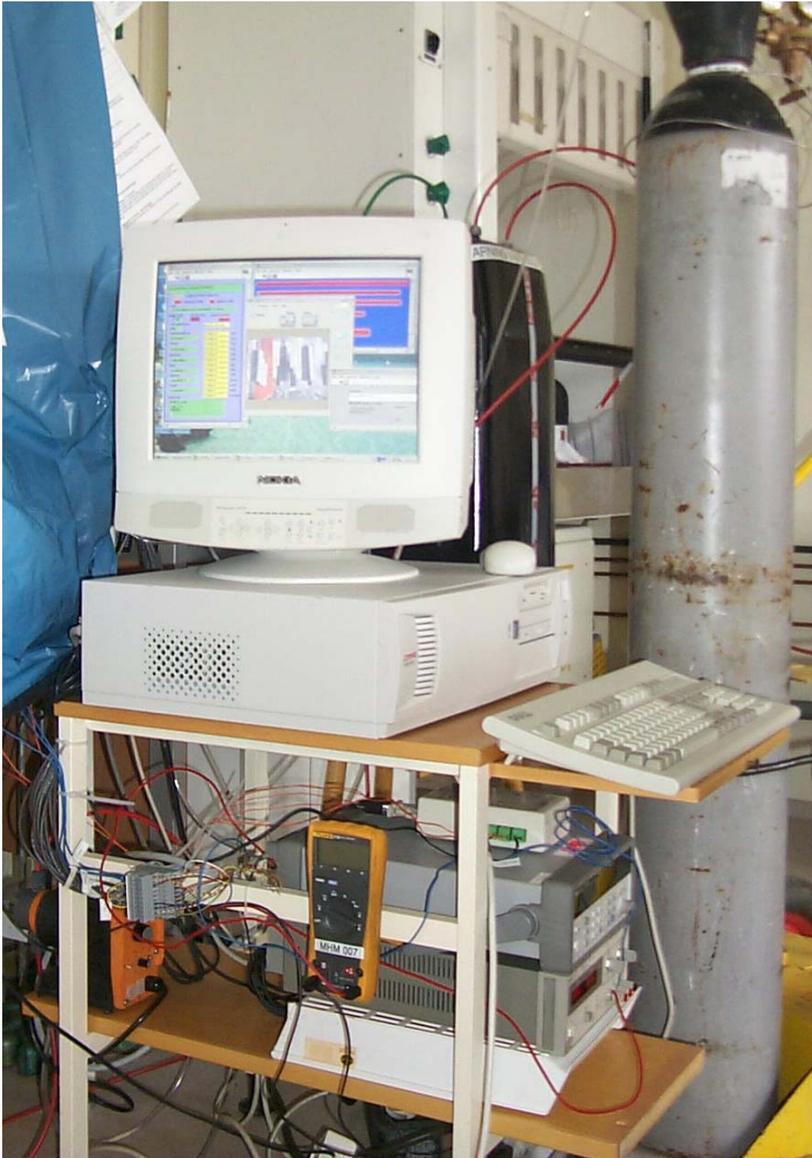
**Figure 2**  
Control and recording environment.

The control and recording environment is shown in Figure 2. The PC with software environment, the control and measurement system, solution storage vessel, dosage pump, etc. can be seen in the figure.

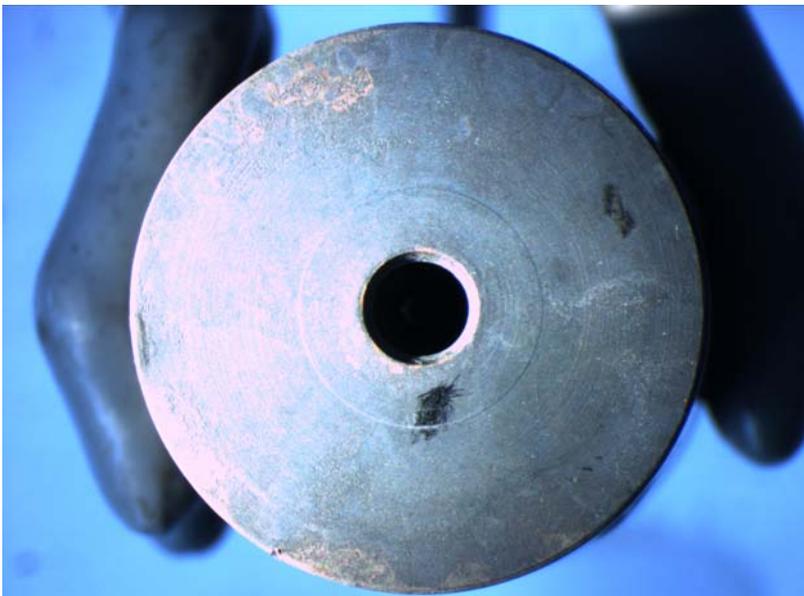
**Figure 9**

The bottom surface of sample 4, soft air flushed, high pressure air flushed, high pressure water flushed, and softly brushed. The diameter is 20 mm.

As there was still some corrosion film left on the surface after this treatment, another step was employed by softly brushing the surface with a soft toothbrush under a water stream. See Figure 9.

All heavier corrosion films were thereby removed from the surface. The root areas of the two different kinds of whiskers are now clearly identified and signs of localized attacks are observed in areas previously observed to be covered with small diameter whiskers. The sample was used in this condition for the following LRS investigations.

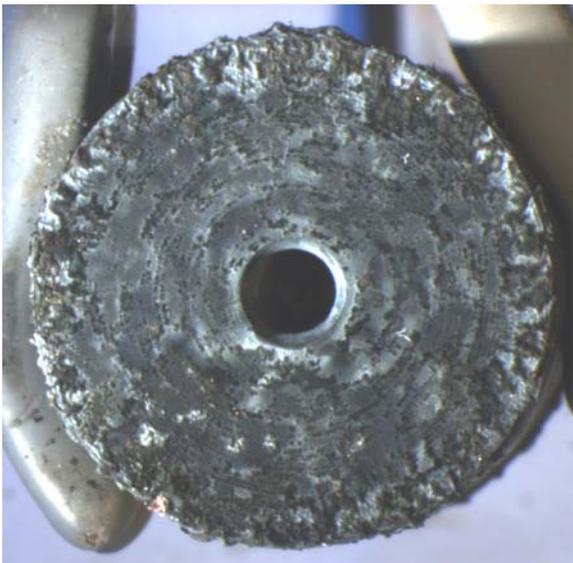
**Figure 10**  
Untreated bottom surface after drainage and drying of sample 1.

The original bottom area of sample 1 is shown in Figure 10. In Figure 11 the condition after soft brushing and air flushing is shown.

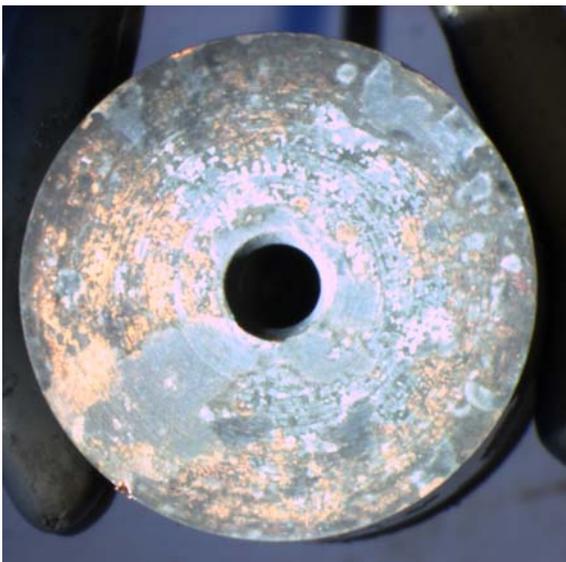
**Figure 11**  
Soft brushed and air flushed bottom surface of sample 1.

The same technique as for sample 4 was used to remove the corrosion products from sample 1. After still some treatment with a soft brush under streaming water, sample 1 was ready for LRS-investigations as accounted below. Also in this case different areas of roots were predetermined with similar results and verifications as for sample 4.

The sample was used after described pre-treatment and had the look as shown in Figure 11. Raman spectra recorded from many points on this surface all show the simultaneous presence of  $\text{Cu}_2\text{O}$  and  $\text{CuO}$  closest to the metal surface. In many cases there seem to be a higher relative concentration of  $\text{Cu}_2\text{O}$  compared with  $\text{CuO}$ , which is quite natural at depths close to the metal surface. It should be noted that all loose material as whiskers and flakes, containing sulphide had already been removed by flushing and brushing from the investigated surface.
