Fatigue fracture surface
characterization and investigation

Author: Magnus Dahlberg, Dave Hannes, Zhouwang Chen
Inspecta Technology AB, Stockholm, Sweden

Report number: 2016:28 ISSN: 2000-0456

Title: Fatigue fracture surface characterization and investigation
Author: Dave Hannes, Magnus Dahlberg, Zhouwang Chen
Inspecta Technology AB,
Stockholm Sweden
Date: 2016-08-24

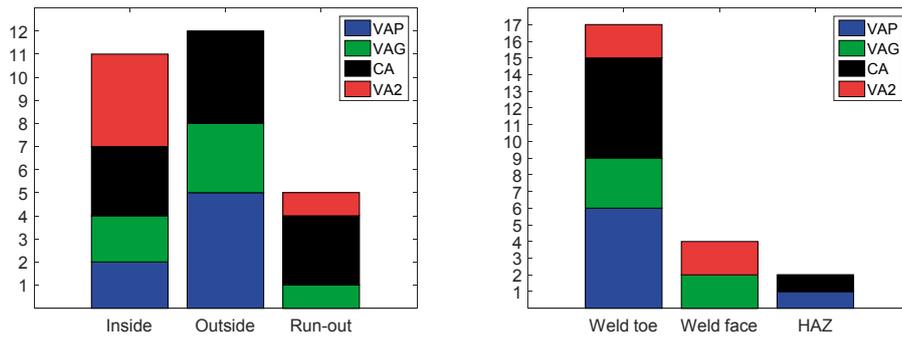
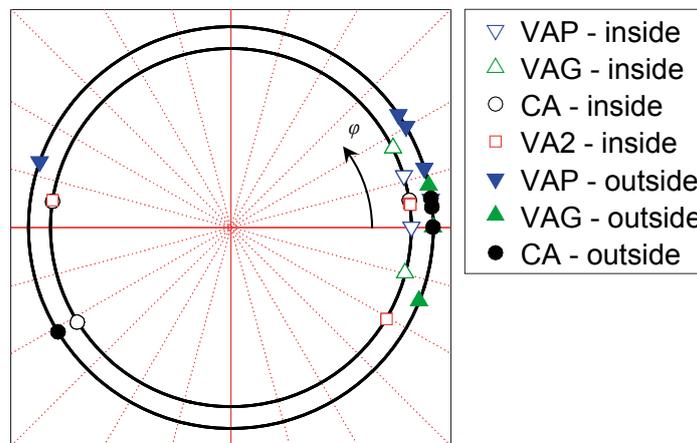
Figure 4 Position of damage initiation for the different test specimens that failed due to fatigue.

(a) Radial position of fatigue initiation and run-outs.

(b) Axial position of fatigue initiation.

(c) Fatigue initiation position for different load types superimposed to specimen cross-section.

From the 23 test specimens that failed due to fatigue about one half initiated from the inside, whereas the other half presented initiation from the outside, see Figure 4 (a). It occurred also that a specimen presented multiple initiation sites with multiple propagating fatigue cracks. Despite the presence of numerous cracks, only one single dominant crack was responsible for causing leakage by penetrating the entire wall thickness of the piping component.

The circumferential position of fatigue initiation φ_{init} was estimated for the fatigue crack that caused leakage, see Table 3. The fatigue initiation positions for the failed specimens are illustrated graphically in Figure 4 (c). It can be observed that the initiation tended to occur in the vicinity of the bending plane, where the strain amplitudes reached maximal values. A dissymmetry can though be noted, as the majority of the fatigue initiations occurred near $\varphi = 0$, and only few fatigue cracks started near $\varphi = \pm 180^\circ$. This observation is most likely related to a relative difference in load amplitude of about 8% between these positions for the considered piping component and experimental set-up. Indeed at $\varphi = 0$ the membrane load introduced by the applied force on the fixtures is in phase with the bending load, resulting in an increased load amplitude, whereas at $\varphi = \pm 180^\circ$ this particular membrane load and the bending load have opposite phase resulting in a lower load amplitude.

These designations are illustrated in Figure 6 and used in both Table 3 and Figure 4 (b). The latter clearly illustrating the weld toe as the more critical position regarding fatigue initiation. All the fatigue cracks that started from the outside were indeed initiated at a weld cap toe, see illustrated in Figure 5 (a). No fatigue cracks started from the weld cap face or HAZ on the outside of the piping component. Cracks starting from the inside of the welded pipe initiated generally from a weld root toe or the weld root face. The latter is illustrated in Figure 5 (b). Still some cracks also initiated from the HAZ on the inside of the specimen.

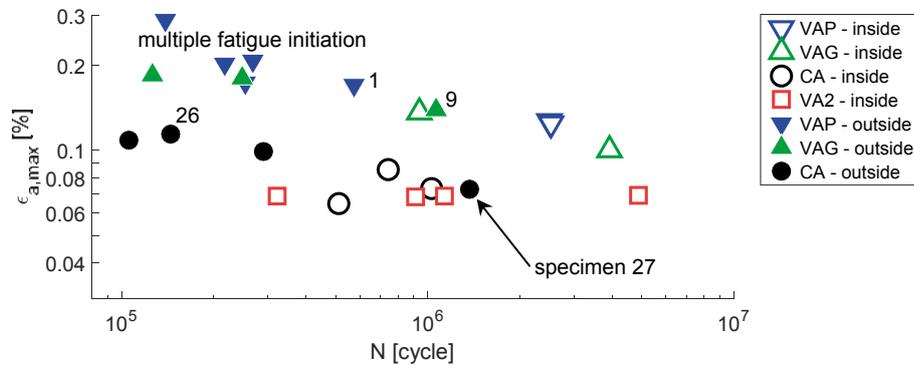
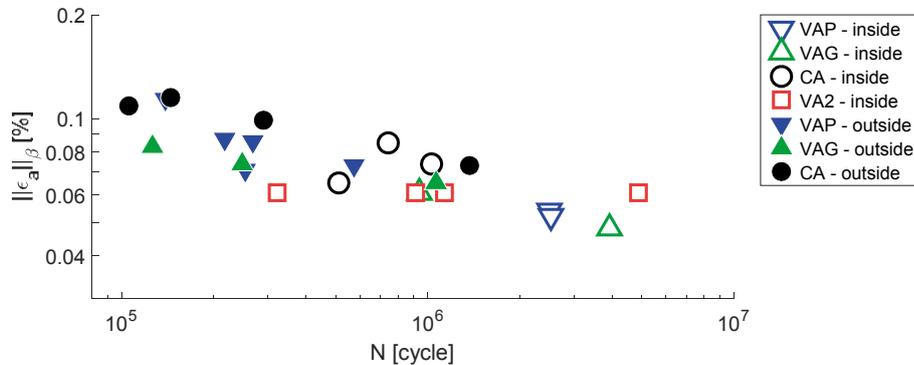
Figure 7 Radial fatigue initiation position in relation to load and number of cycles for the failed tests.

(a) Maximal nominal strain amplitude vs total number of cycles.

(b) Beta-norm vs total number of cycles.

Figure 7 represents a nominal measure of the load amplitude as function of the total number of cycles the specimen was subjected to prior to leakage detection. Figure 7 (a) shows the maximal nominal strain amplitude and the beta-norm defined in [2] is represented in Figure 7 (b). The strain measures in Figure 7 (a) and (b) are both based on the recorded nominal strain for each piping component using a strain gage situated in the bending plane, see Figure 2. These strains do obviously differ from the local strains the material near the welding joint experienced due to the presence of the weld material and stress concentrations at the junctions of the joint. Figure 4 (a) did not directly reveal a clear relation between radial fatigue initiation position and load type, however Figure 7 points at the radial fatigue initiation position being related to the severity of the load type. It can namely be observed that initiation

Specimen 27 may appear as a clear exception in Figure 7(a), as this piping component presented a dominant fatigue crack causing leakage starting from the outside although being subjected to a HCF load, but the investigation of its fracture surface also revealed at a different circumferential position a well-developed fatigue crack that had initiated from the inside, see Figure 8 (c), which agrees well with the prevailing damage process at HCF. The fatigue crack that started from the inside did not penetrate the entire wall thickness of specimen 27, but reached an

Specimens 1, 9 and 26 have been subjected to continued fatigue crack growth even after leakage was detected and when the internal pressure of 70 bar no longer could be sustained. The data points for these three specimens are marked in Figure 7 (a). When fatigue crack propagation was allowed to be continued the fatigue crack progressed to cover a major part of the specimens' cross-section, see for instance Figure 8(d), where the fatigue crack in specimen 9 almost covers half of its cross-section. The fracture surfaces for these three specimens did therefore no longer represent the state at leakage. Given the negative load ratio, continued fatigue testing introduced considerable wear of the fracture surfaces. The sustained damage of the fracture surfaces rendered some features, such as the initiation position, uncertain or at least more challenging to determine. This may explain why both specimens 1 and 9 seem to present atypical radial initiation positions in Figure 7 (a).

As illustrated in Figure 7 (a), different fatigue damage processes were identified to act at LCF and HCF. Caution is therefore recommended when extrapolating results for instance obtained for LCF to the HCF domain or vice versa. Similarly the effect of solutions to improve fatigue life of the piping component will differ considerably depending on the prevailing damage process. Removal of the weld cap by grinding or any other finishing operation is often proposed to be beneficial to the fatigue resistance of a piping component. This is indeed the case as long as
