SSI Rapport

2003:16 LIA PAHAPILL, ANNE RULKOV, RAIVO RAJAMÄE
AND GUSTAV ÅKERBLOM

Radon in Estonian dwellings
Results from a National Radon Survey

Radon in Estonian dwellings - Results from a National Radon Survey

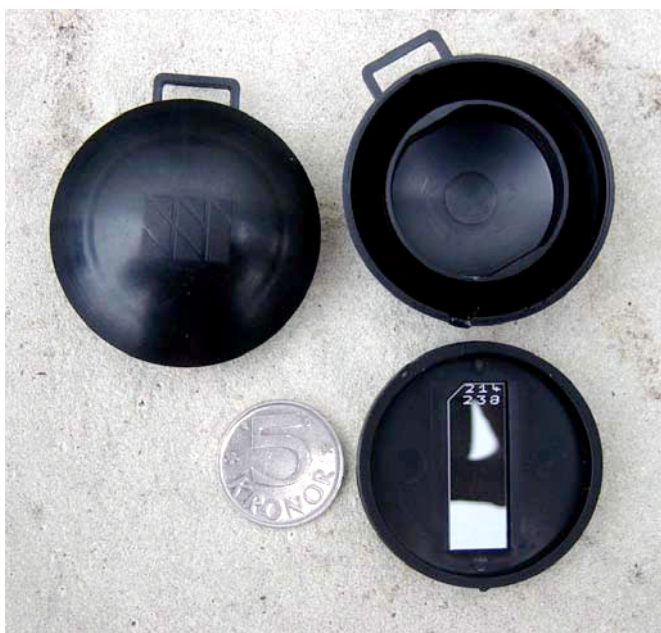
Figure 4. The alpha-track film detector used in the Estonian National Radon Survey. The detector holder on the right is open to show the plastic film used. The detector holder is closed during the measurement. Radon gas seeps into the detector through a thin slot between the lid and the bottom of the detector holder.

All indoor radon measurements in the Estonian-Swedish Radon Projects were made with passive alpha-track film detectors (Figure 4). The measurements were made using CR-39 (polyallyl diglycol carbonate) alpha-track film detector material from TASL Ltd, Bristol, UK. For the measurements, the film is placed in a closed cup holder of electrically conductive plastic. These detectors were originally designed by the National Radiological Protection Board (NRPB), UK and they have been further developed by the Swedish Radiation Protection Institute (SSI) [6]. After chemical etching in a 20% NaOH solution (17 hours, etching temperature 68 °C), the films were evaluated by an image analysis system using the GIPSRAD software developed by Image House a/s in Denmark. Etching and analysis of the films was done at the Estonian Radiation Protection Centre. Sensitivity calibration of the detectors was performed at SSI. The uncertainty in this method ranges from 5–10 %, the detection limit is 10 Bqm⁻².

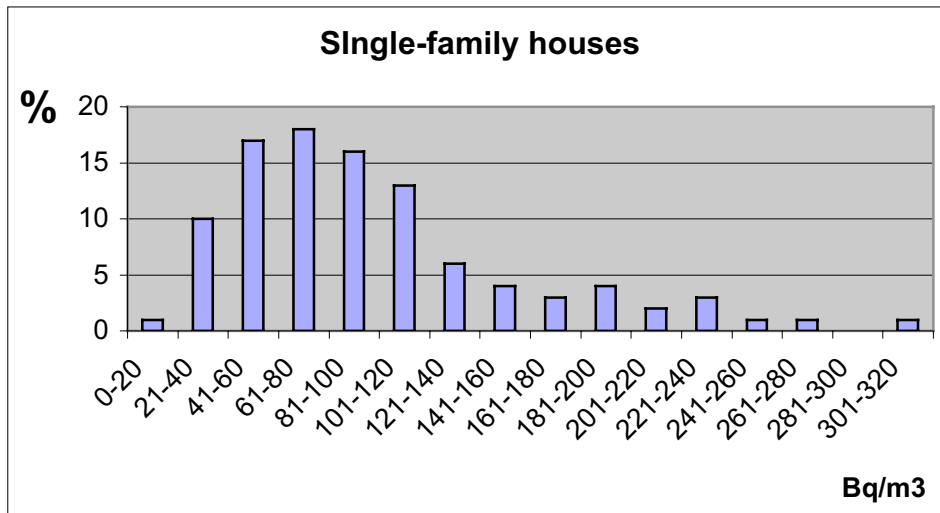
Figure 8. Distribution of radon activity concentration in single-family houses in Estonia. (The percentage of values indicated in the interval 301-320 reflects the total number of values exceeding 300Bqm⁻³.)

For radon gas the arithmetic mean in single-family houses was 103 Bq m^{-3} . The activity concentration distribution is shown in Figure 8. All measurements in multi-apartment buildings in this survey were made in flats on the ground floor. Thus, the radon concentrations in multi-apartment buildings are only representative for the flats on the ground floor. In those dwellings, the average arithmetic mean value was 78 Bq m^{-3} . Figure 9 shows the activity concentration distribution in these dwellings. In flats above the ground floor, radon concentrations are much lower, normally less than 30 Bq m^{-3} . Assuming that, on average, the Estonian apartment houses have 3 storeys, 20 - 30% of the population living in multi-apartment buildings live in flats on the first floor. On this assumption, the arithmetic mean for the radon concentration in dwellings in multi-apartment buildings would be 44 Bq m^{-3} . The mean radon activity concentration for all Estonian dwellings (in single family houses and in flats in multi-apartment buildings) will be 60 Bq m^{-3} , given that the assumptions above are correct.

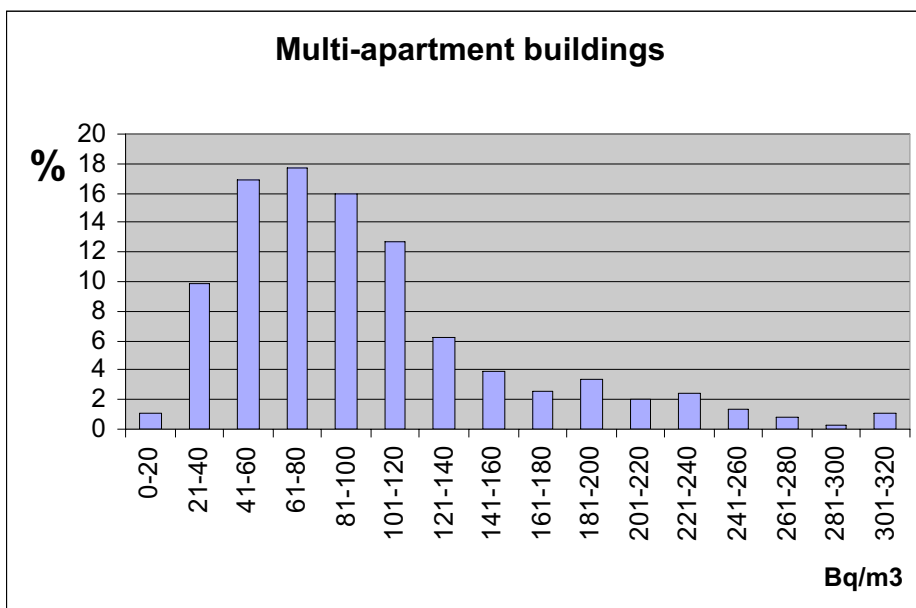
Figure 9. Distribution of radon activity concentration in ground floor flats in Estonian multi-apartment buildings. (The percentage of values indicated in the interval 301-320 reflects the total number of values exceeding 300Bqm⁻³.)
