SKI report 2008:29
SSI report 2008:17

Safety and Radiation Protection at Swedish Nuclear Power Plants 2007

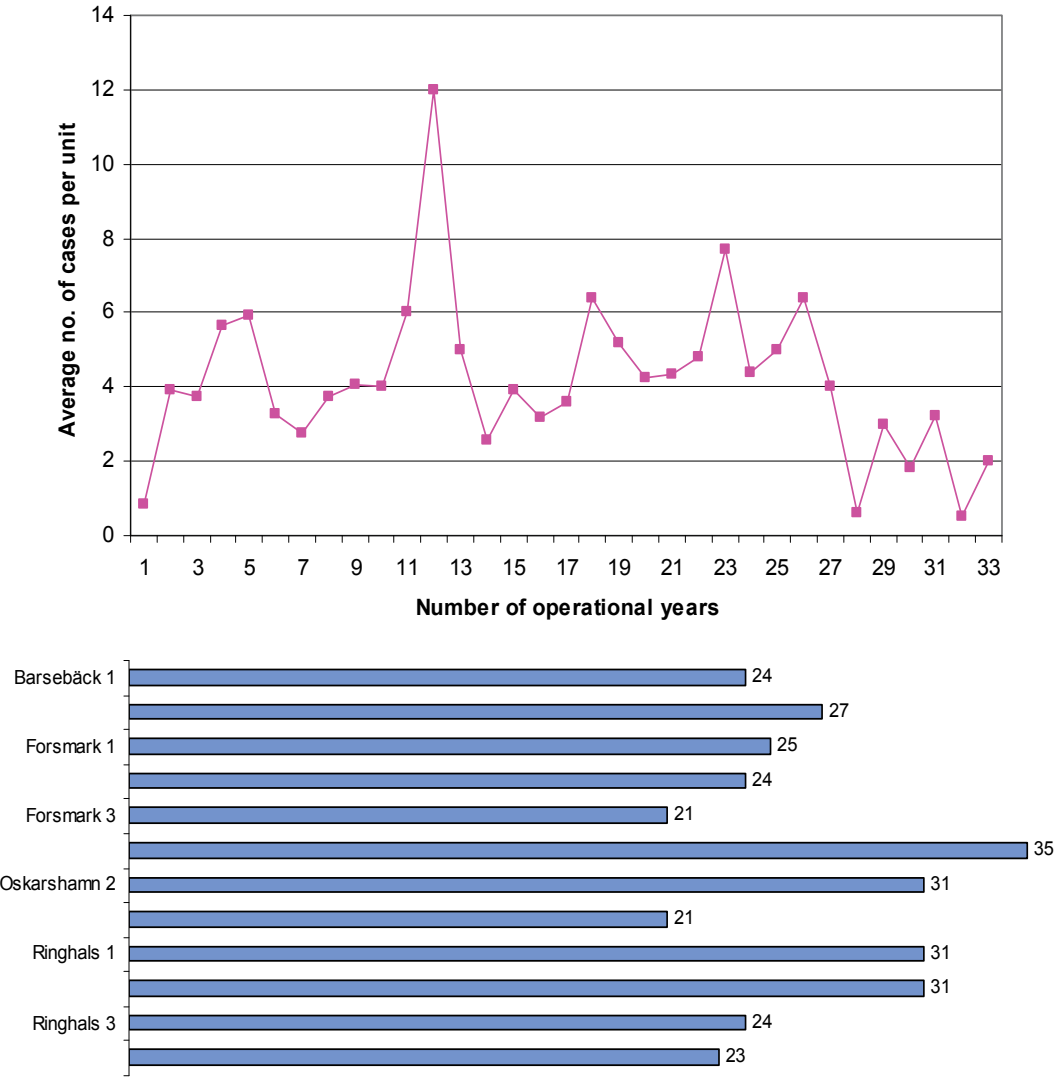
Diagram 1. The upper diagram shows the average number of reported events per plant and operational year for all the Swedish plants. The diagram includes events in pressure vessels, piping, and other mechanical components except steam generators. The lower diagram shows the operational age of the plants.

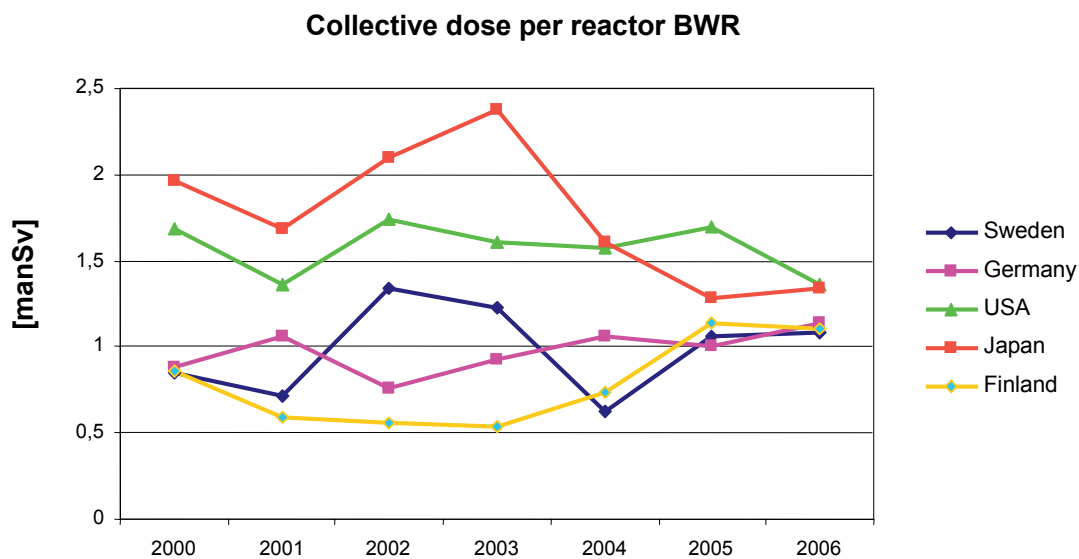
Diagram 4: Swedish collective doses for BWR (boiling water reactors) in an international comparison. Source: OECD/NEA, Information System of Occupational Exposure.

During 2007 the total collective dose (effective dose to personnel, including contractors) at the Swedish nuclear power plants was 8.8 manSv. The dose is the same order of magnitude as the average for the past five years (8.9 manSv). *Diagrams 4 and 5* show the collective doses at the Swedish facilities in an international comparison for BWR and PWR plants. Countries with comparable reactors to the Swedish plants with respect to design and age have been chosen for the comparison. Diagram 6 shows the dose trend for personnel at the nuclear power plants over the period 1996 – 2007.
